APPENDIX D
SITE PHOTOGRAPHS

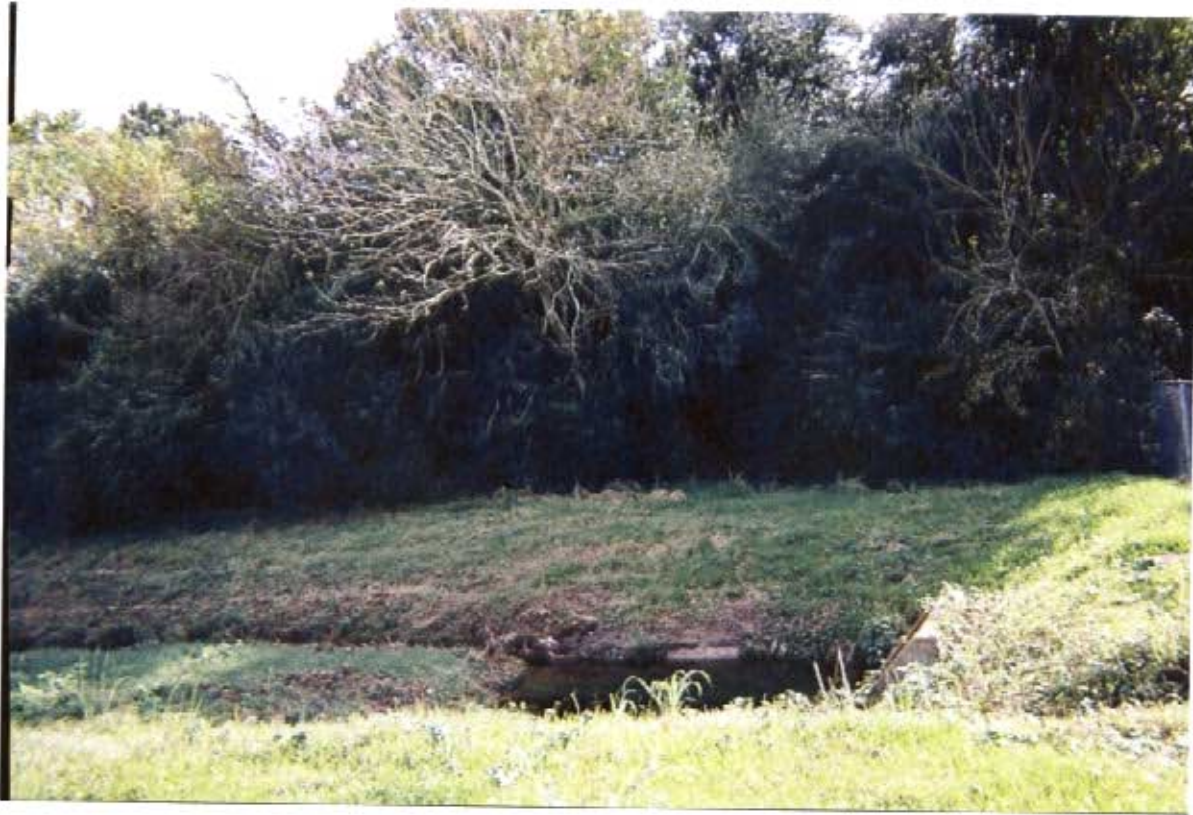
Photograph 1 - Drainage ditch located adjacent to the north boundary of the property.

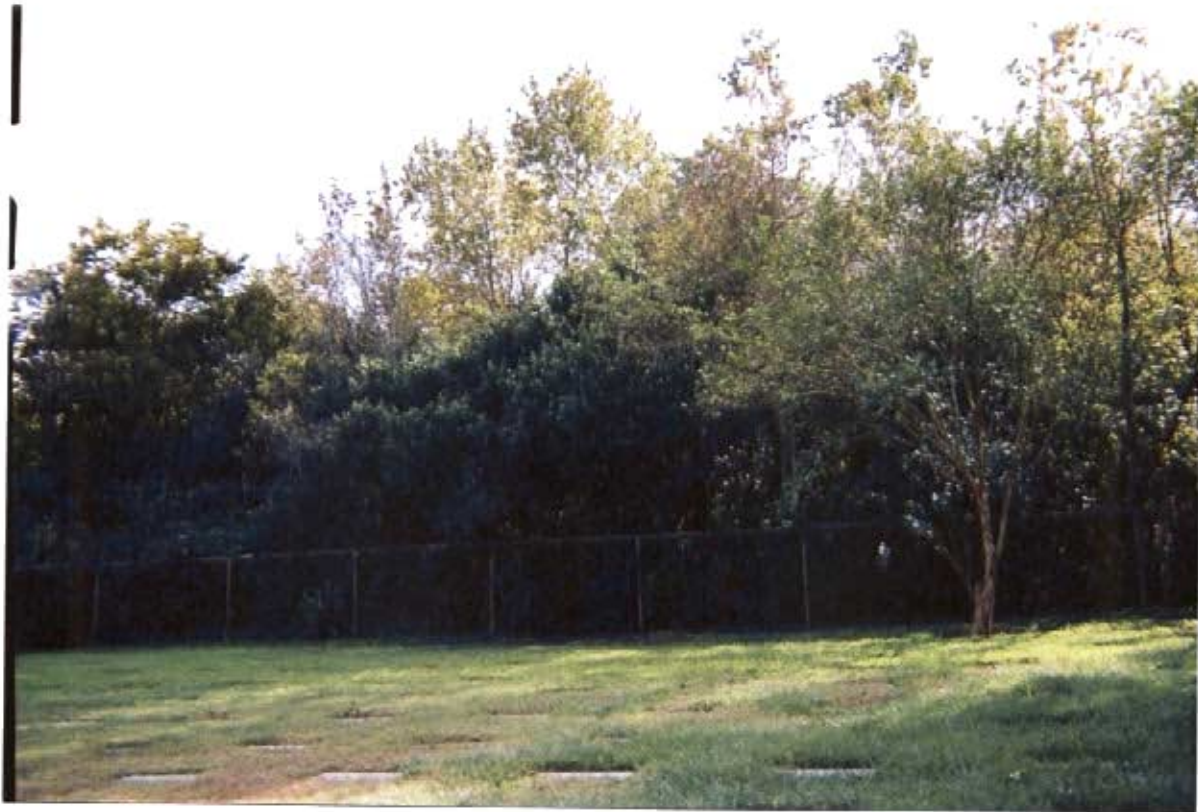
Photograph 2 – View of the property along the north property boundary, looking south.

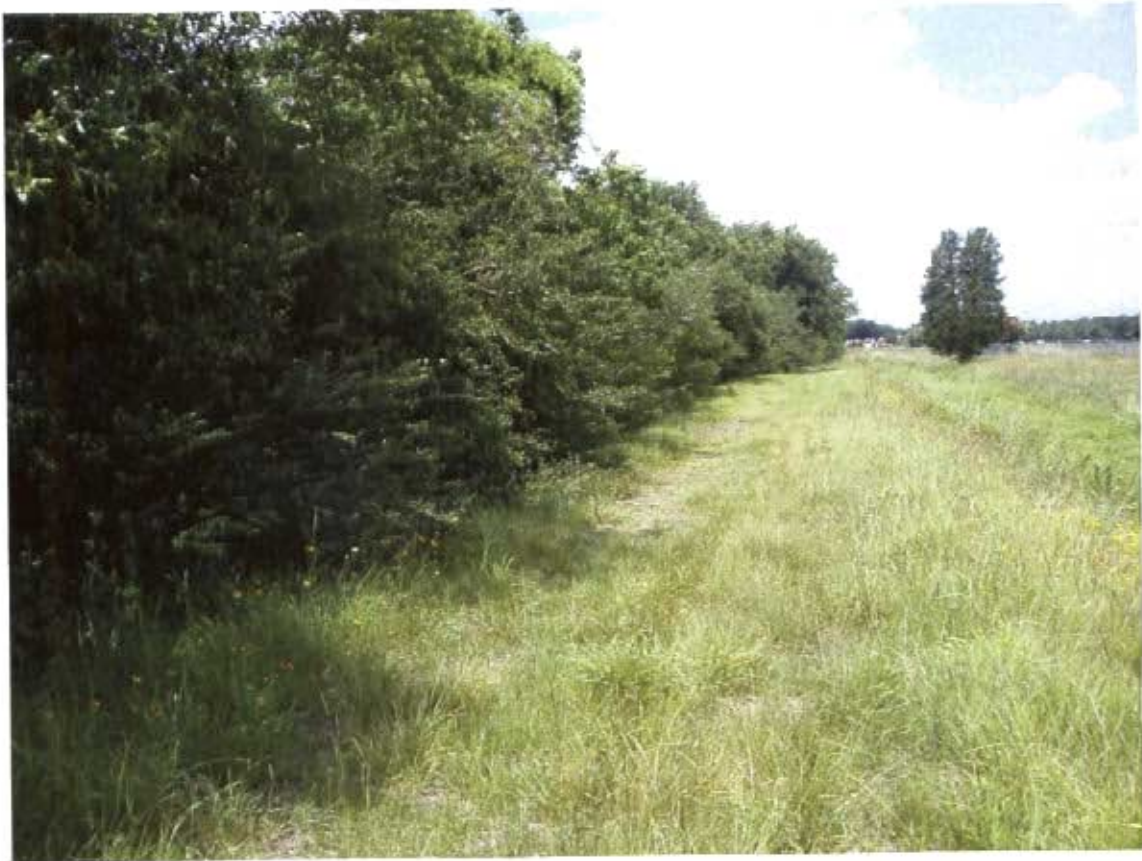
Photograph 3 - View of north boundary of the property from northeast corner, looking west toward cemetery.

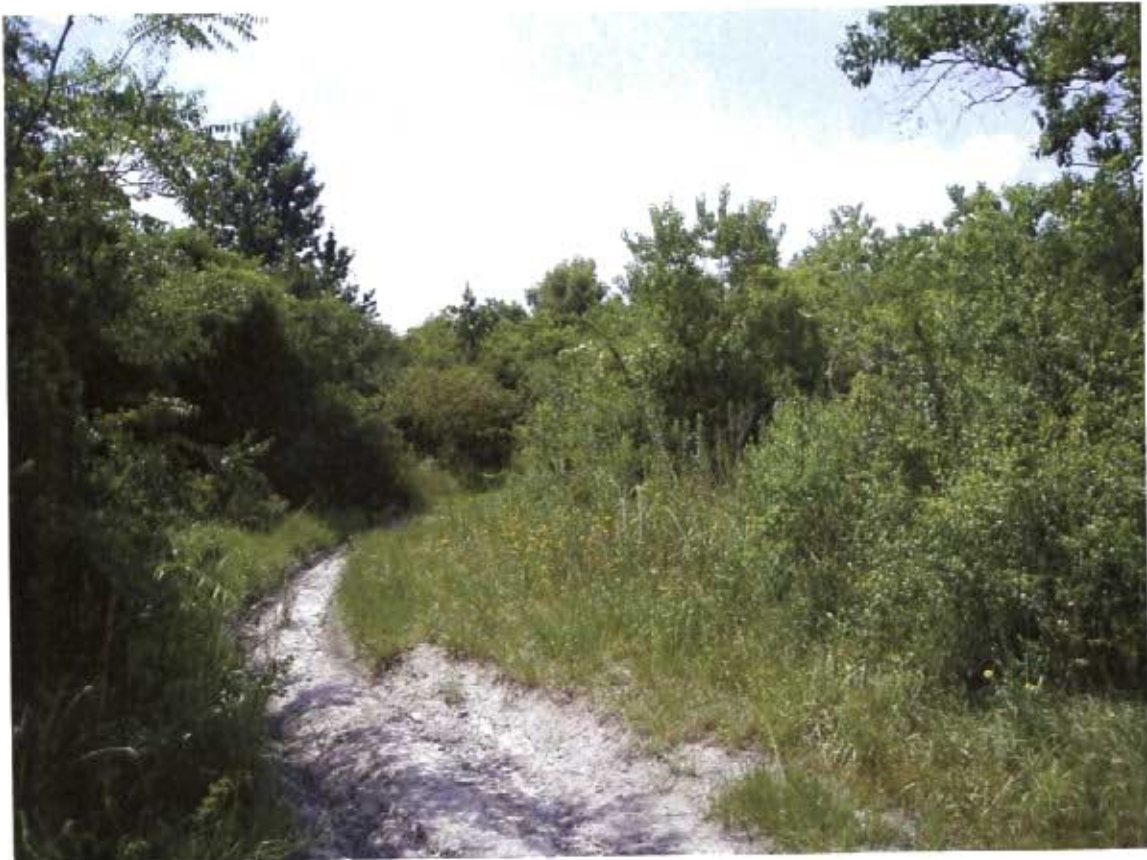
Photograph 4 - View of central portion of property in dirt trail area.

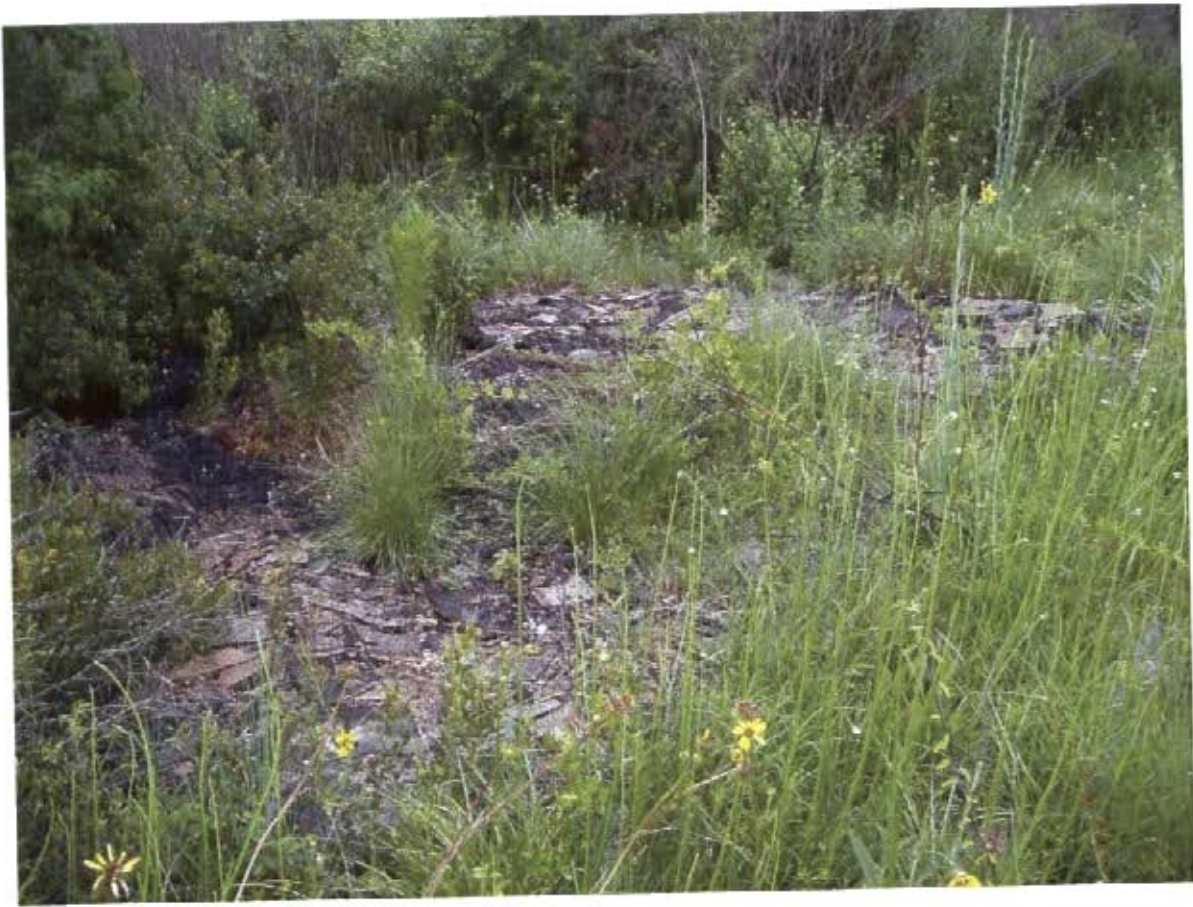
Photograph 5 – View of shingle debris pile observed in central portion of property.
