MEMORANDUM OF AGREEMENT
AMONG THE NATIONAL CEMETERY ADMINISTRATION OF THE U.S. DEPARTMENT OF
VETERANS AFFAIRS, THE TONAWANDA SENECA NATION, THE NEW YORK STATE
HISTORIC PRESERVATION OFFICE, AND THE ESTATE OF LEROY VEENENDAAL,
REGARDING ESTABLISHMENT OF A NEW NATIONAL CEMETERY AT AN
APPROXIMATELY 132-ACRE SITE LOCATED AT 1232 INDIAN FALLS ROAD, GENESEE
COUNTY, NY (SHPO Project Review No.12PR2608)

**Phase 3 Data Recovery Plan for the Indian Falls V.A. Precontact Site (A03712.000035)
at the Proposed Western New York U.S. Department of Veterans Affairs Cemetery Location
in East Pembroke, New York**

**Western New York National Cemetery
Traffic Study**

**Western New York National Cemetery
Supplemental Traffic Study – Indian Falls Road**

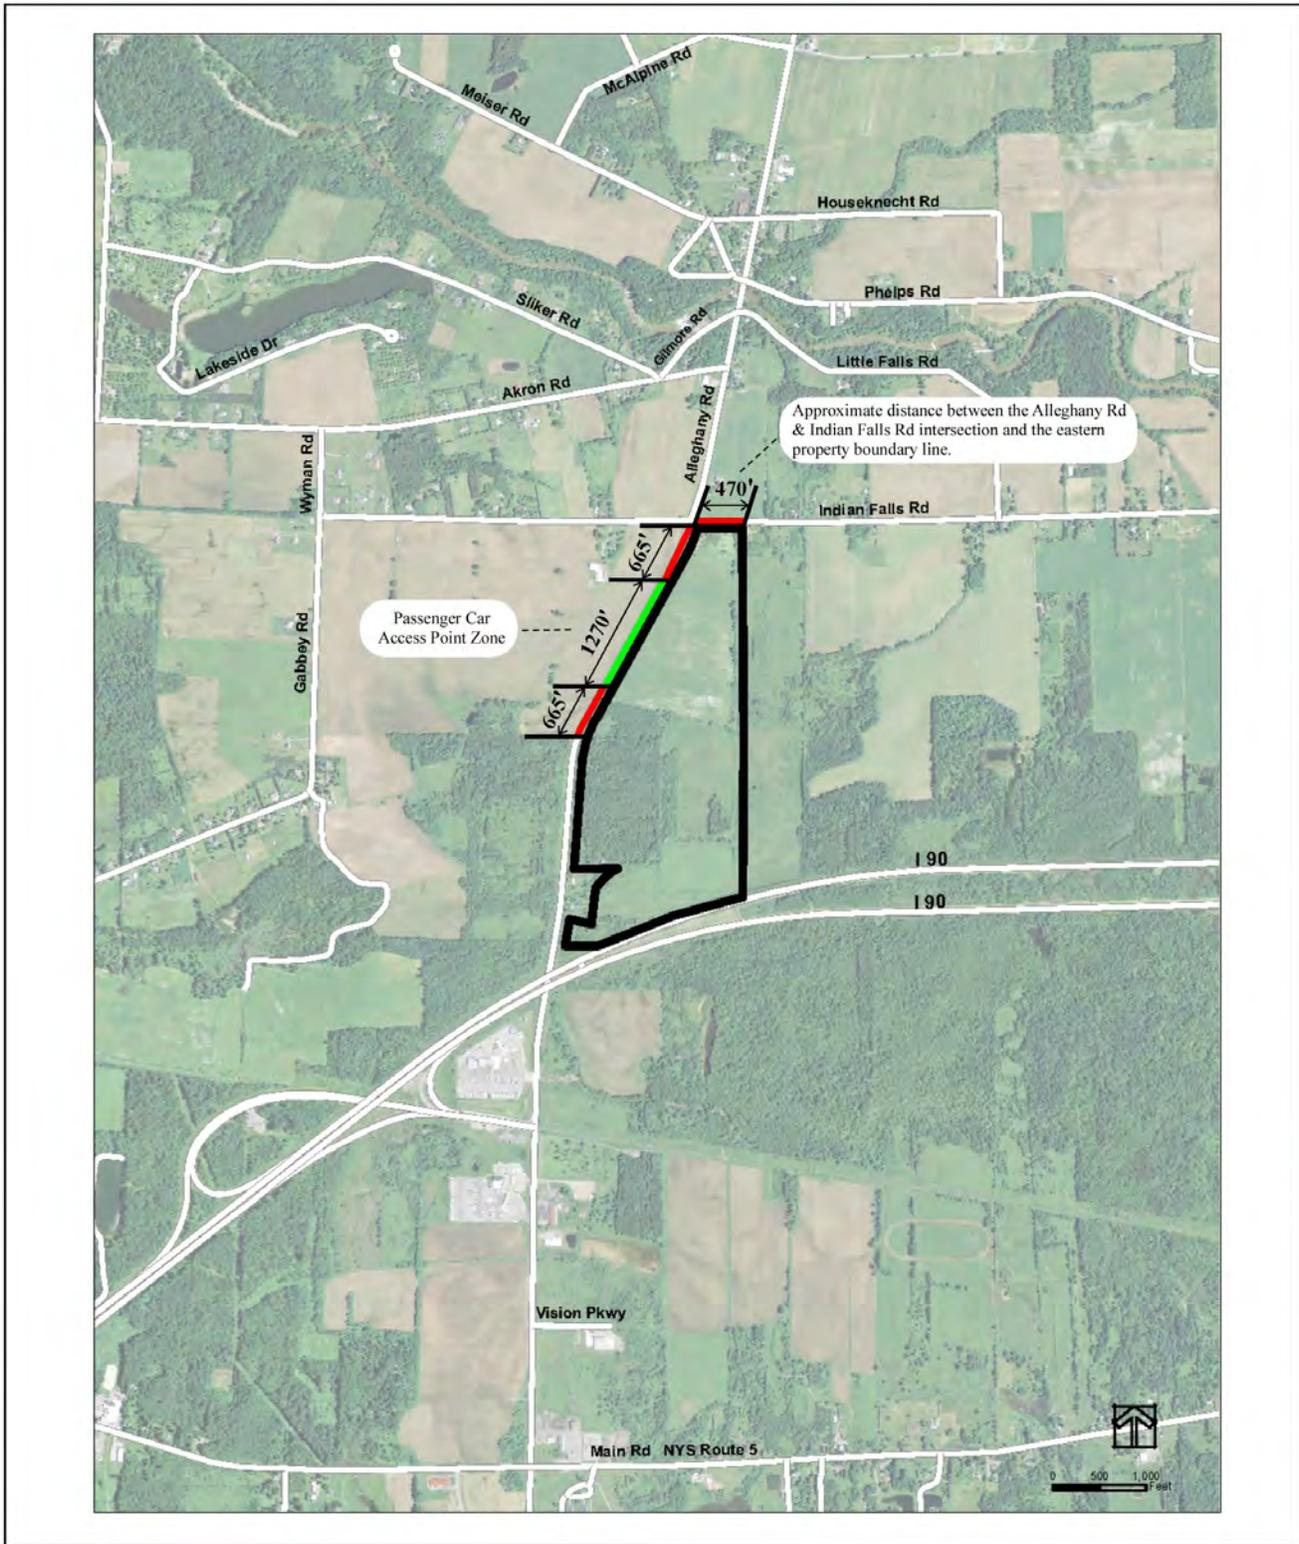
Western New York National Cemetery
Route 77 & Indian Falls Road
Passenger Car Access Point Zone Map

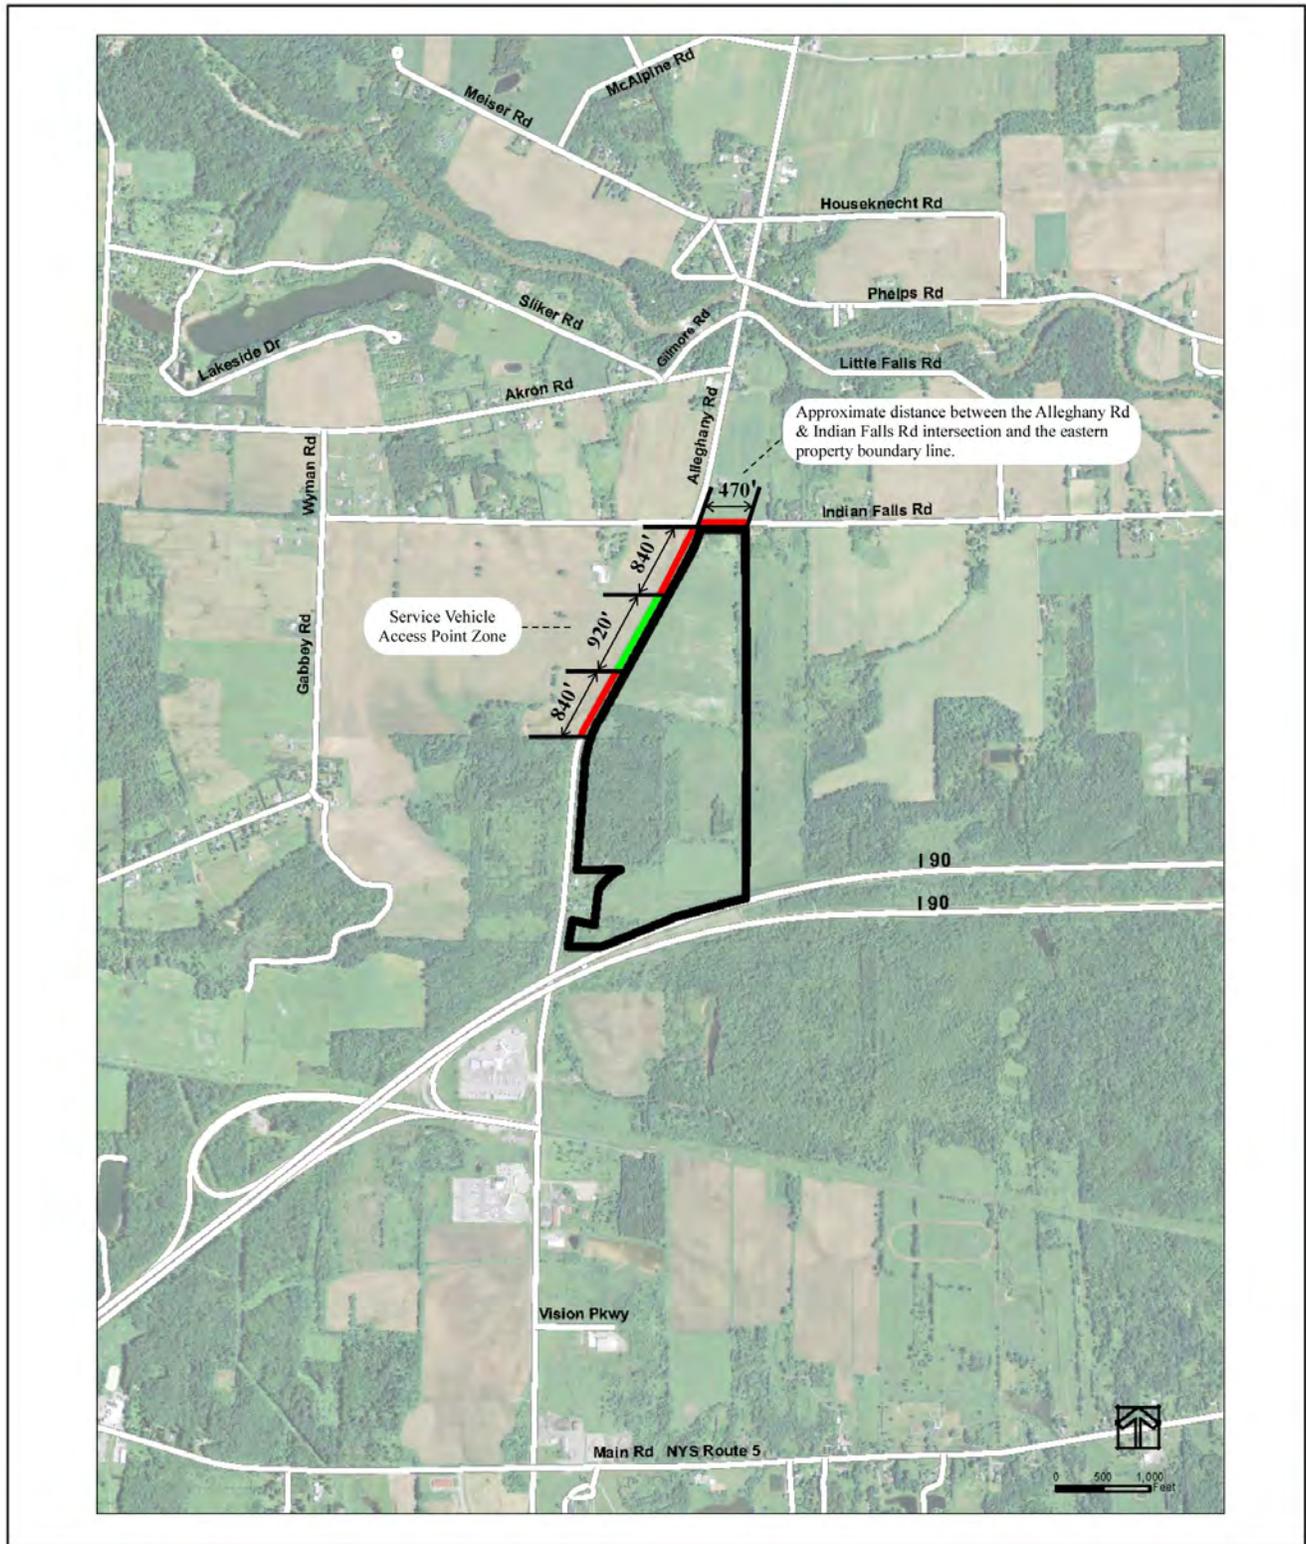
Figure 8

Western New York National Cemetery
Route 77 & Indian Falls Road
Service Vehicle Access Point Zone Map

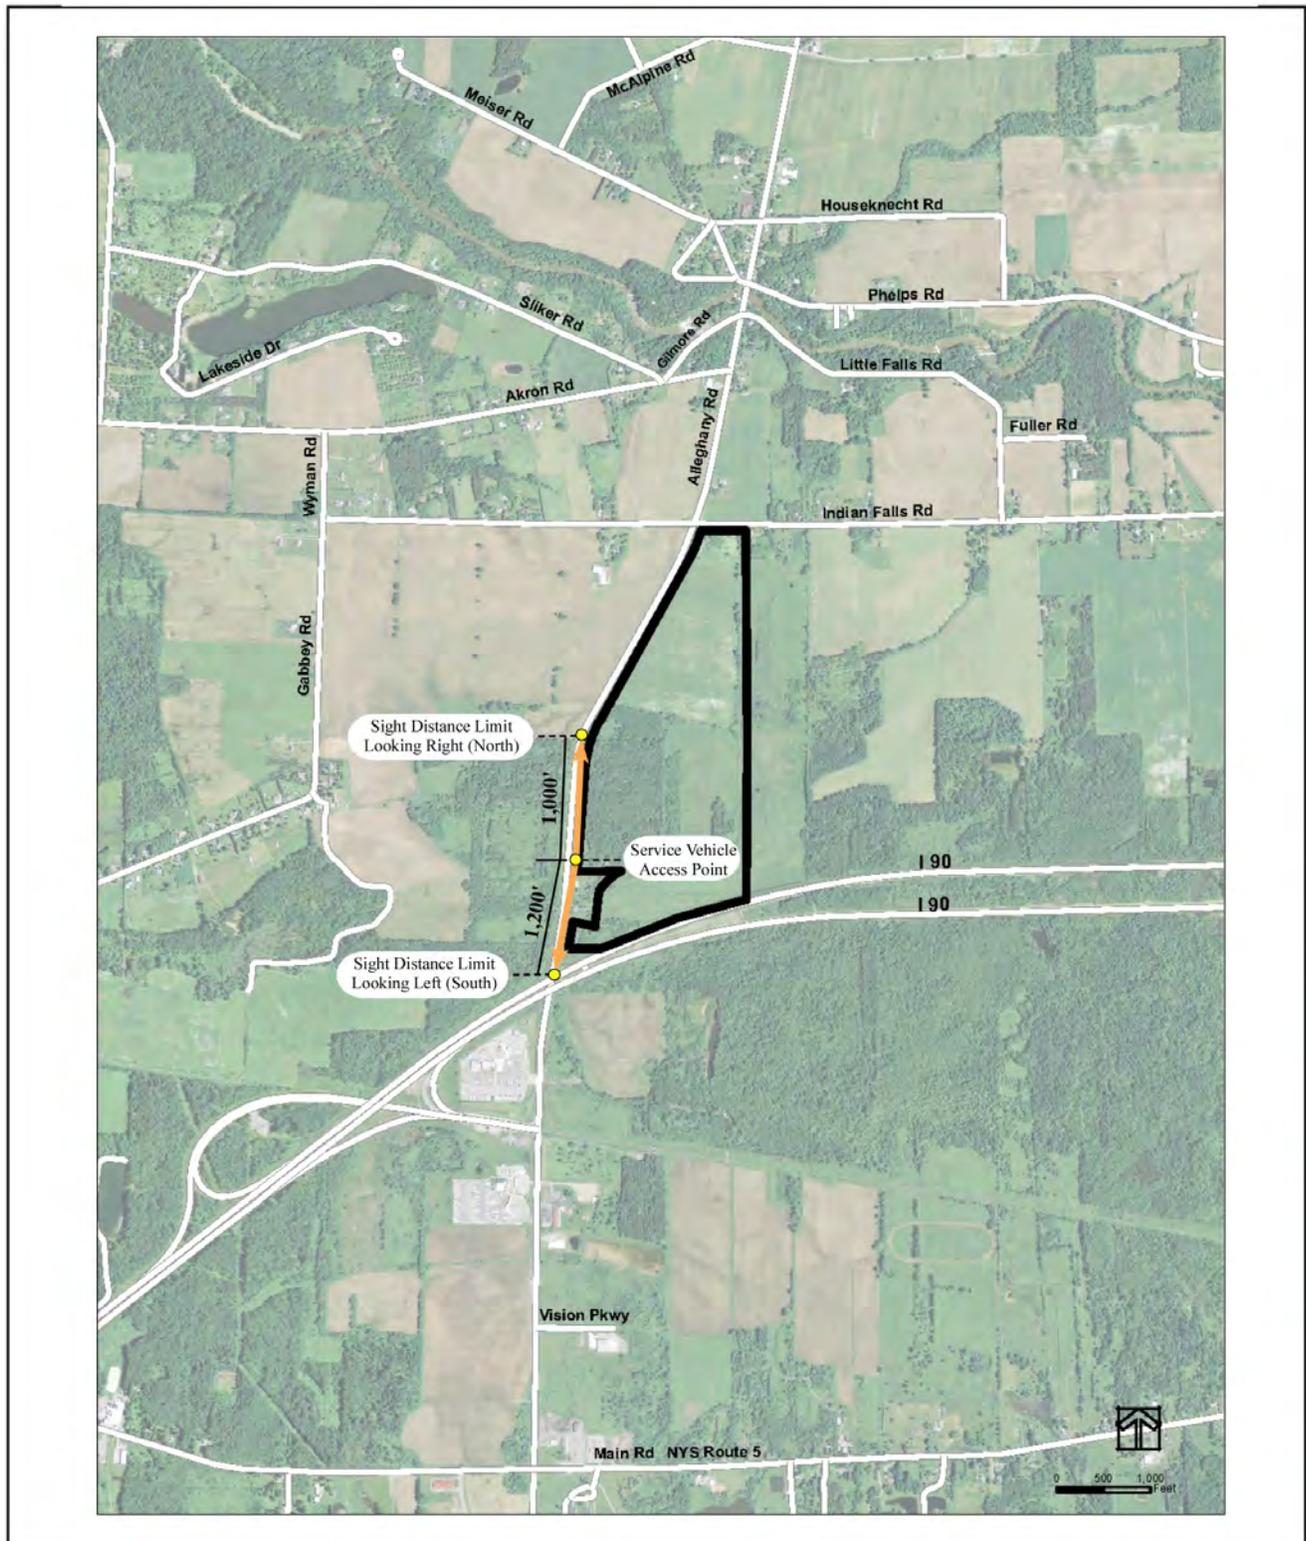
Figure 9

Western New York National Cemetery
Route 77 & Indian Falls Road
Service Vehicle Access - Observed Intersection Sight Distance

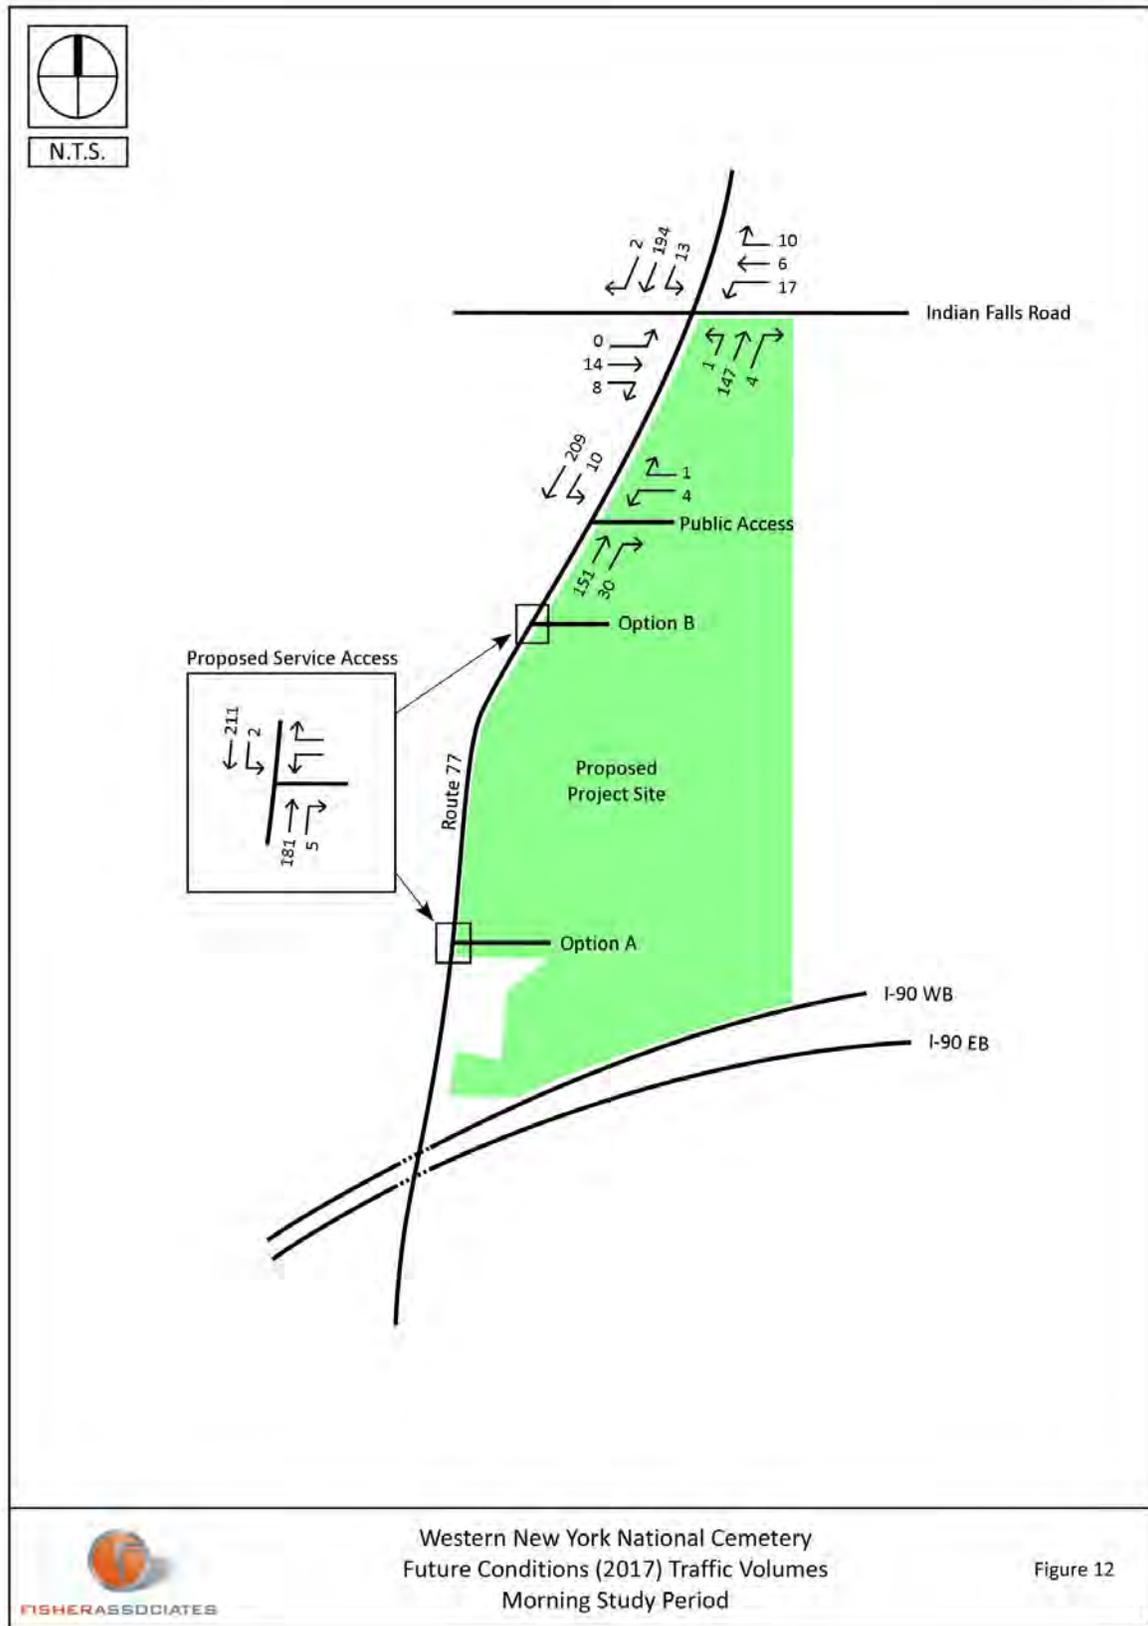
Figure 12

Western New York National Cemetery
 Future Conditions (2017) Traffic Volumes
 Morning Study Period

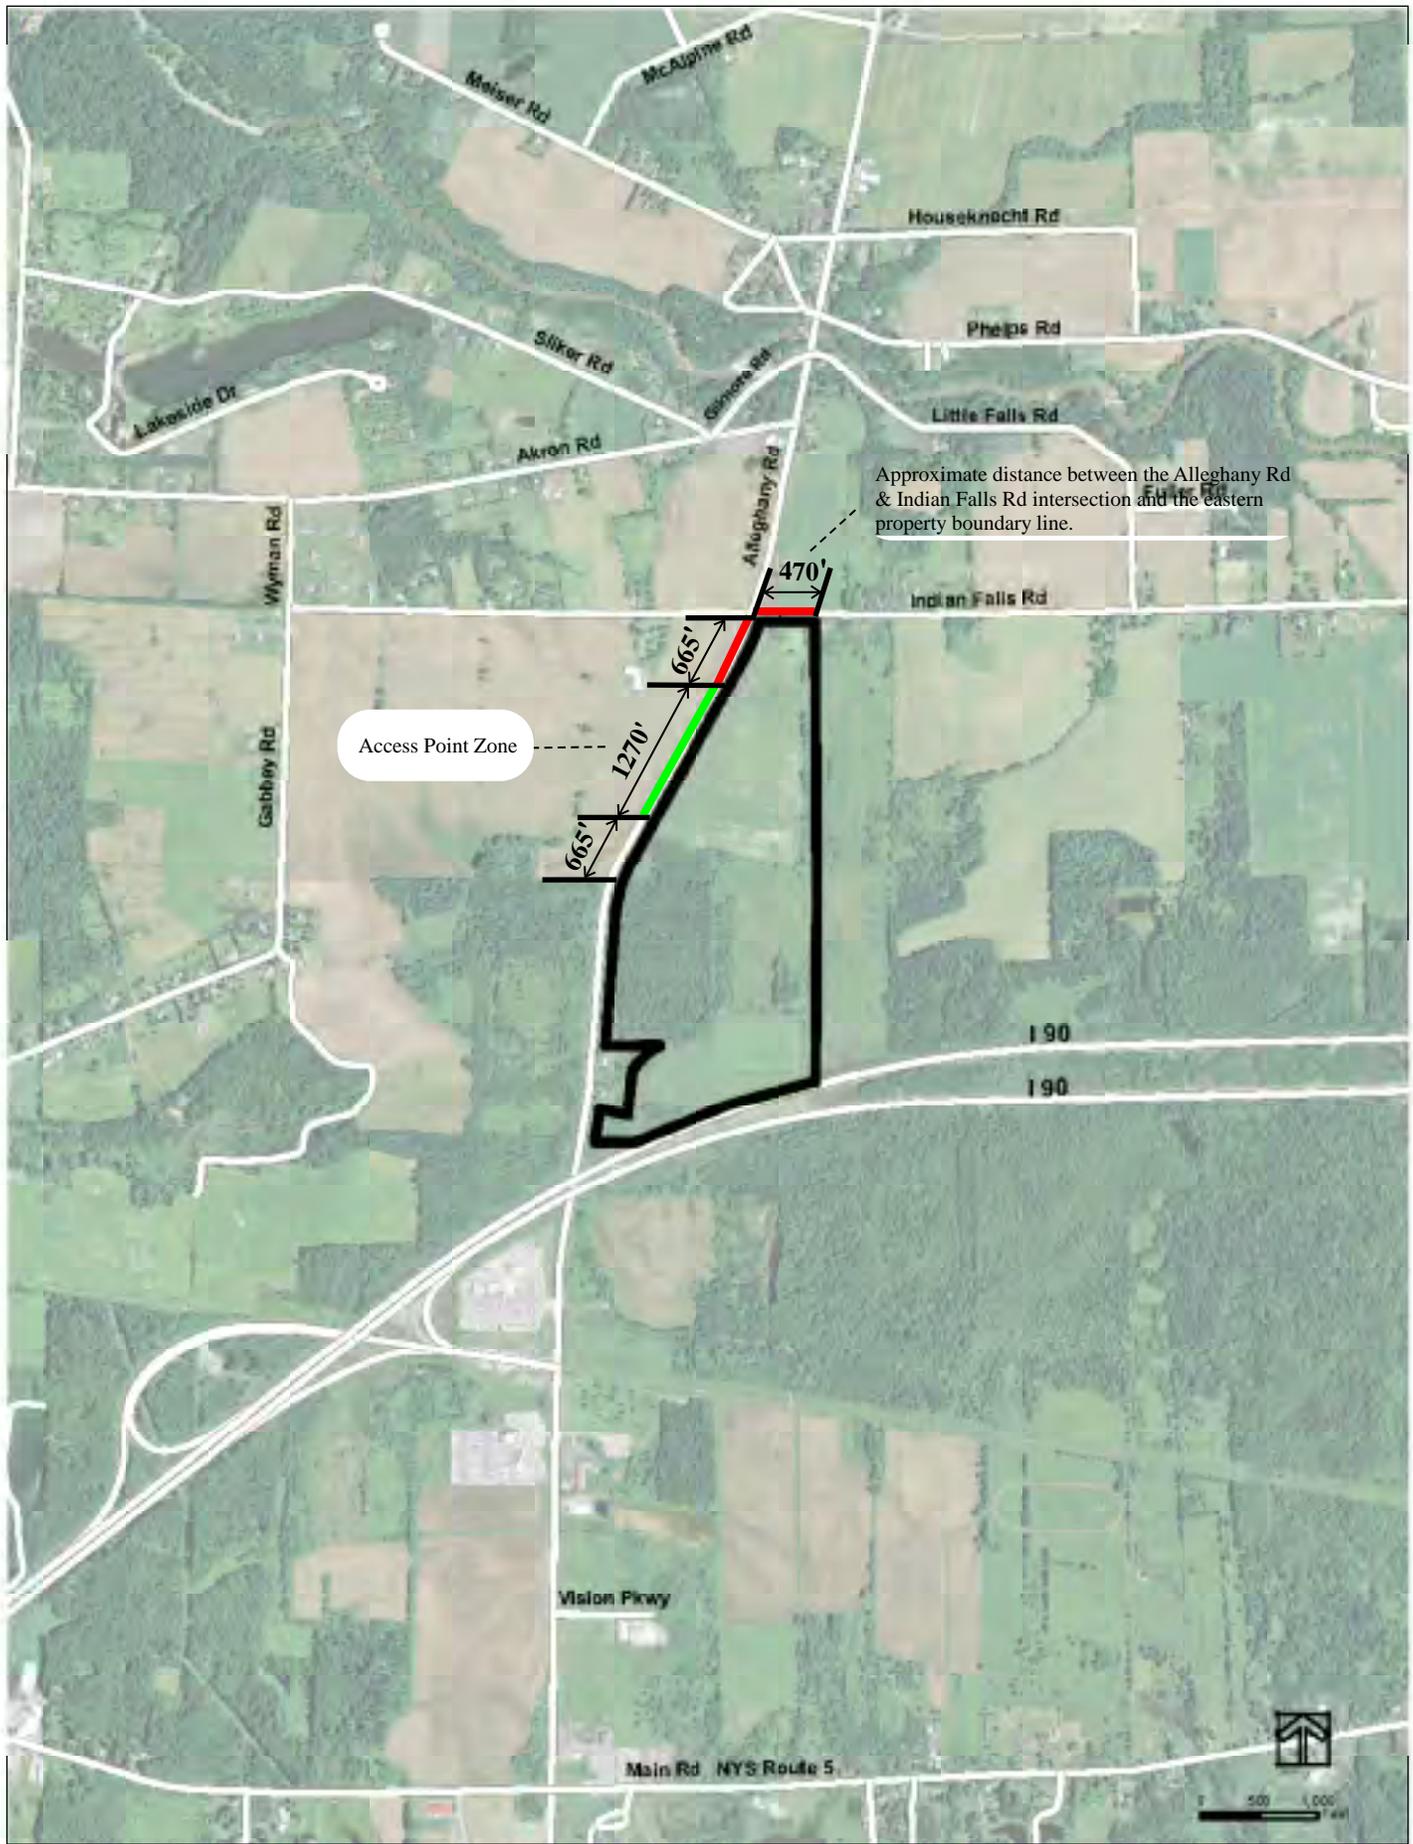
Figure 1
 4/10/15

Western New York National Cemetery
 Allegheny Road & Indian Falls Road
 Access Zone Map

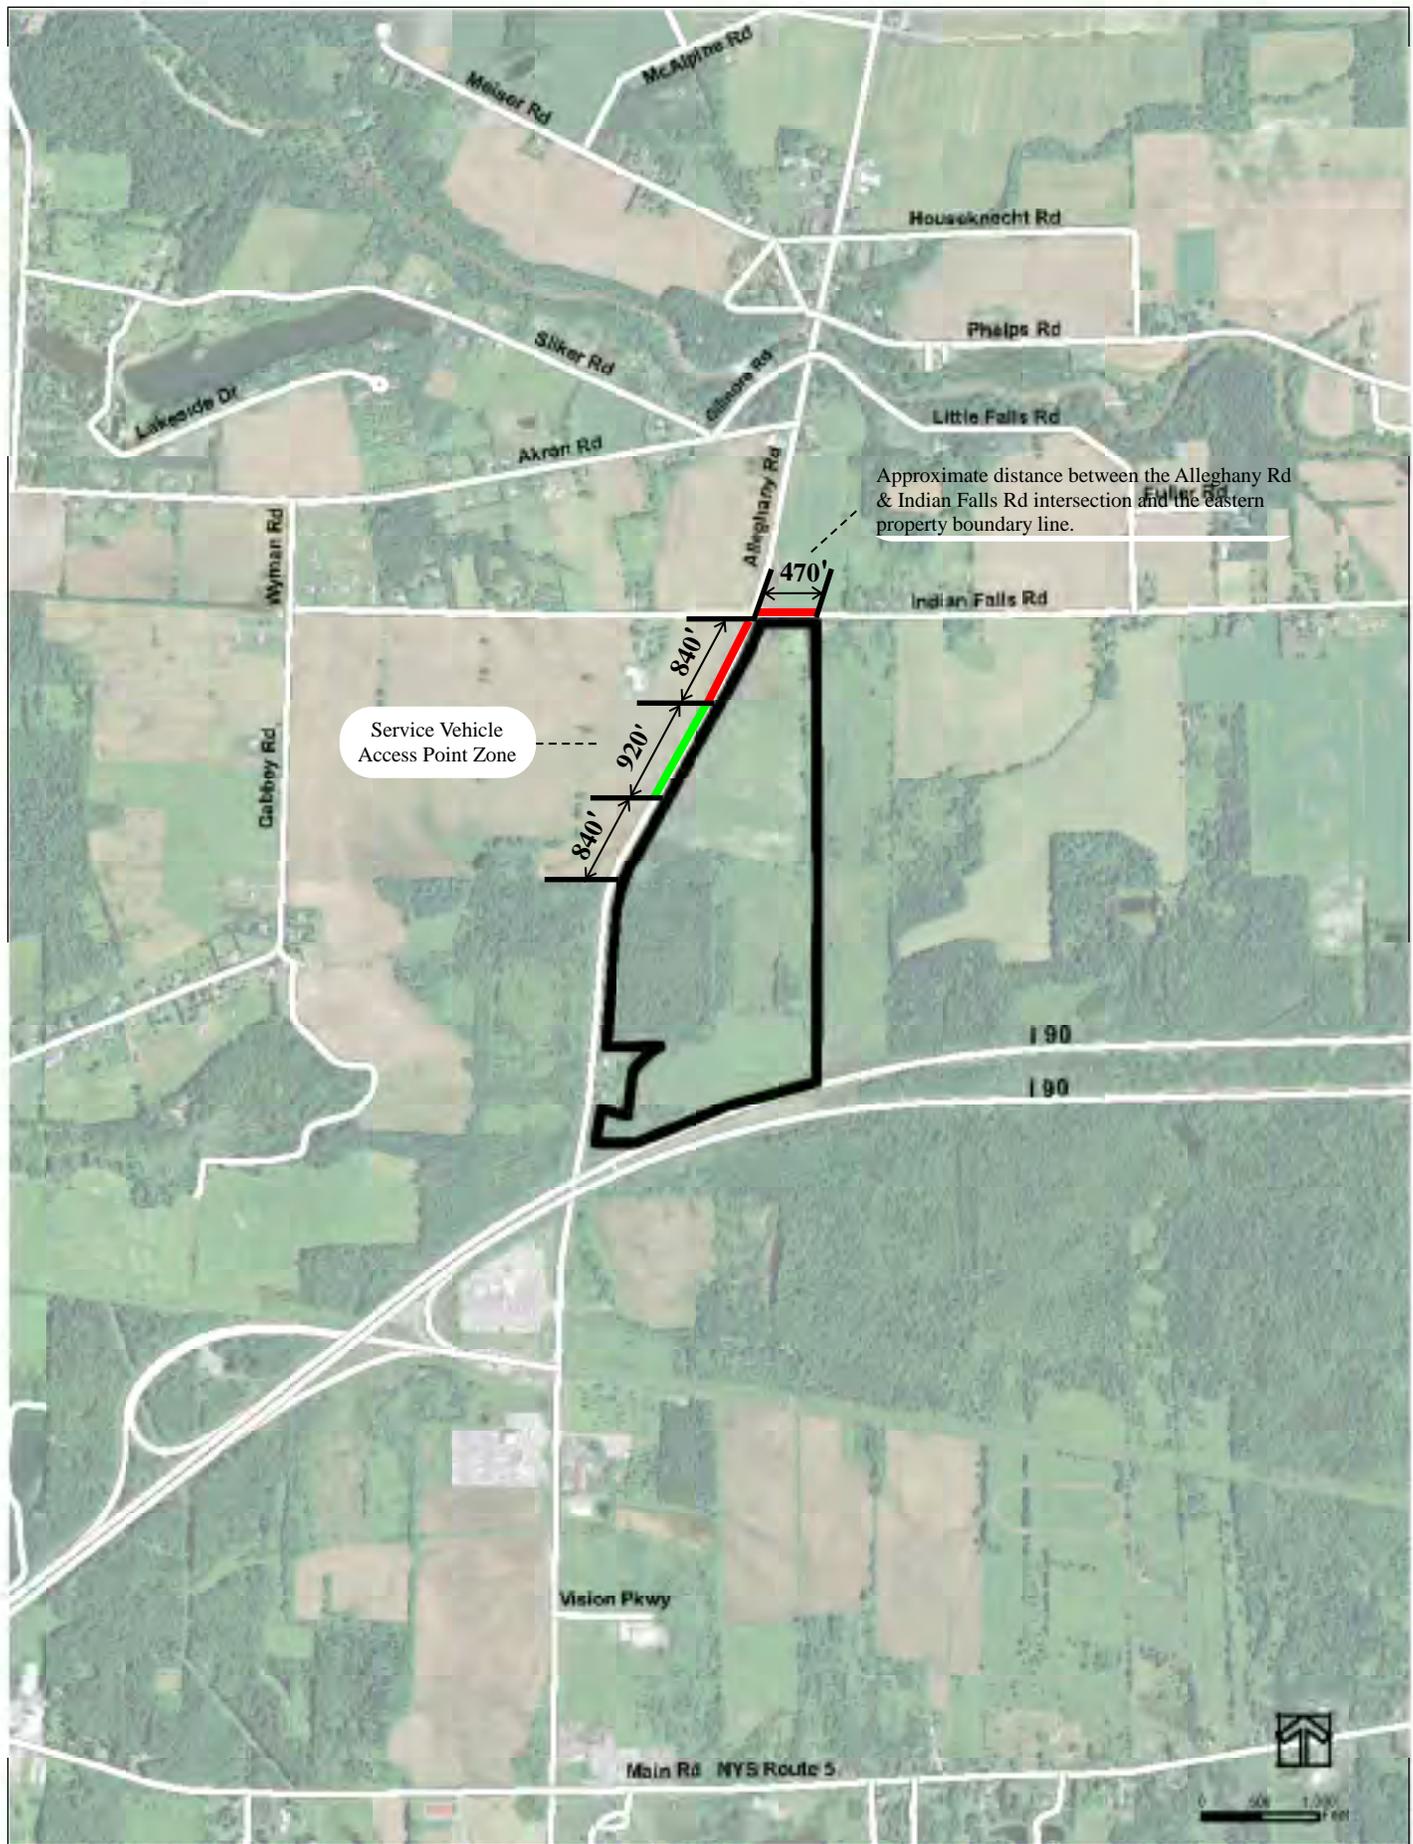
Figure 2
 4/13/15

Western New York National Cemetery
 Allegheny Road & Indian Falls Road
 Service Vehicle Access Point Zone Map

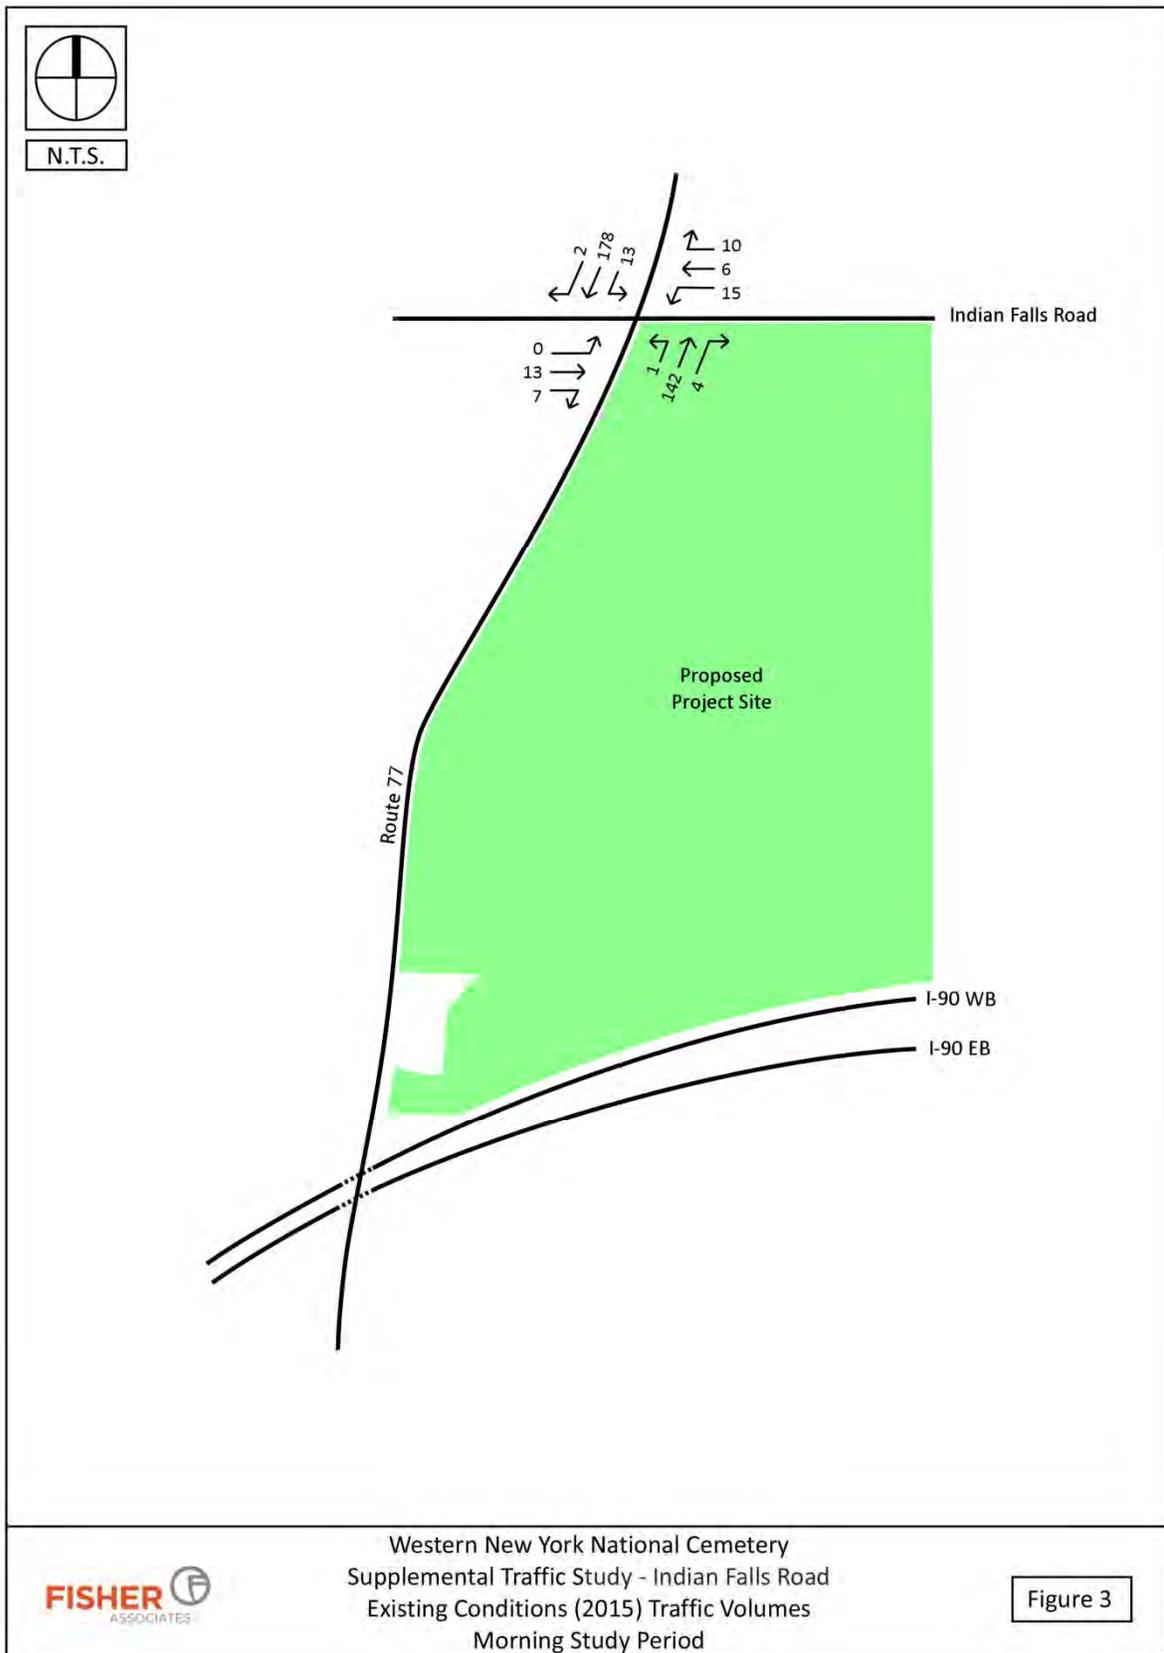
Figure 3

Western New York National Cemetery
Supplemental Traffic Study - Indian Falls Road
Existing Conditions (2015) Traffic Volumes
Morning Study Period

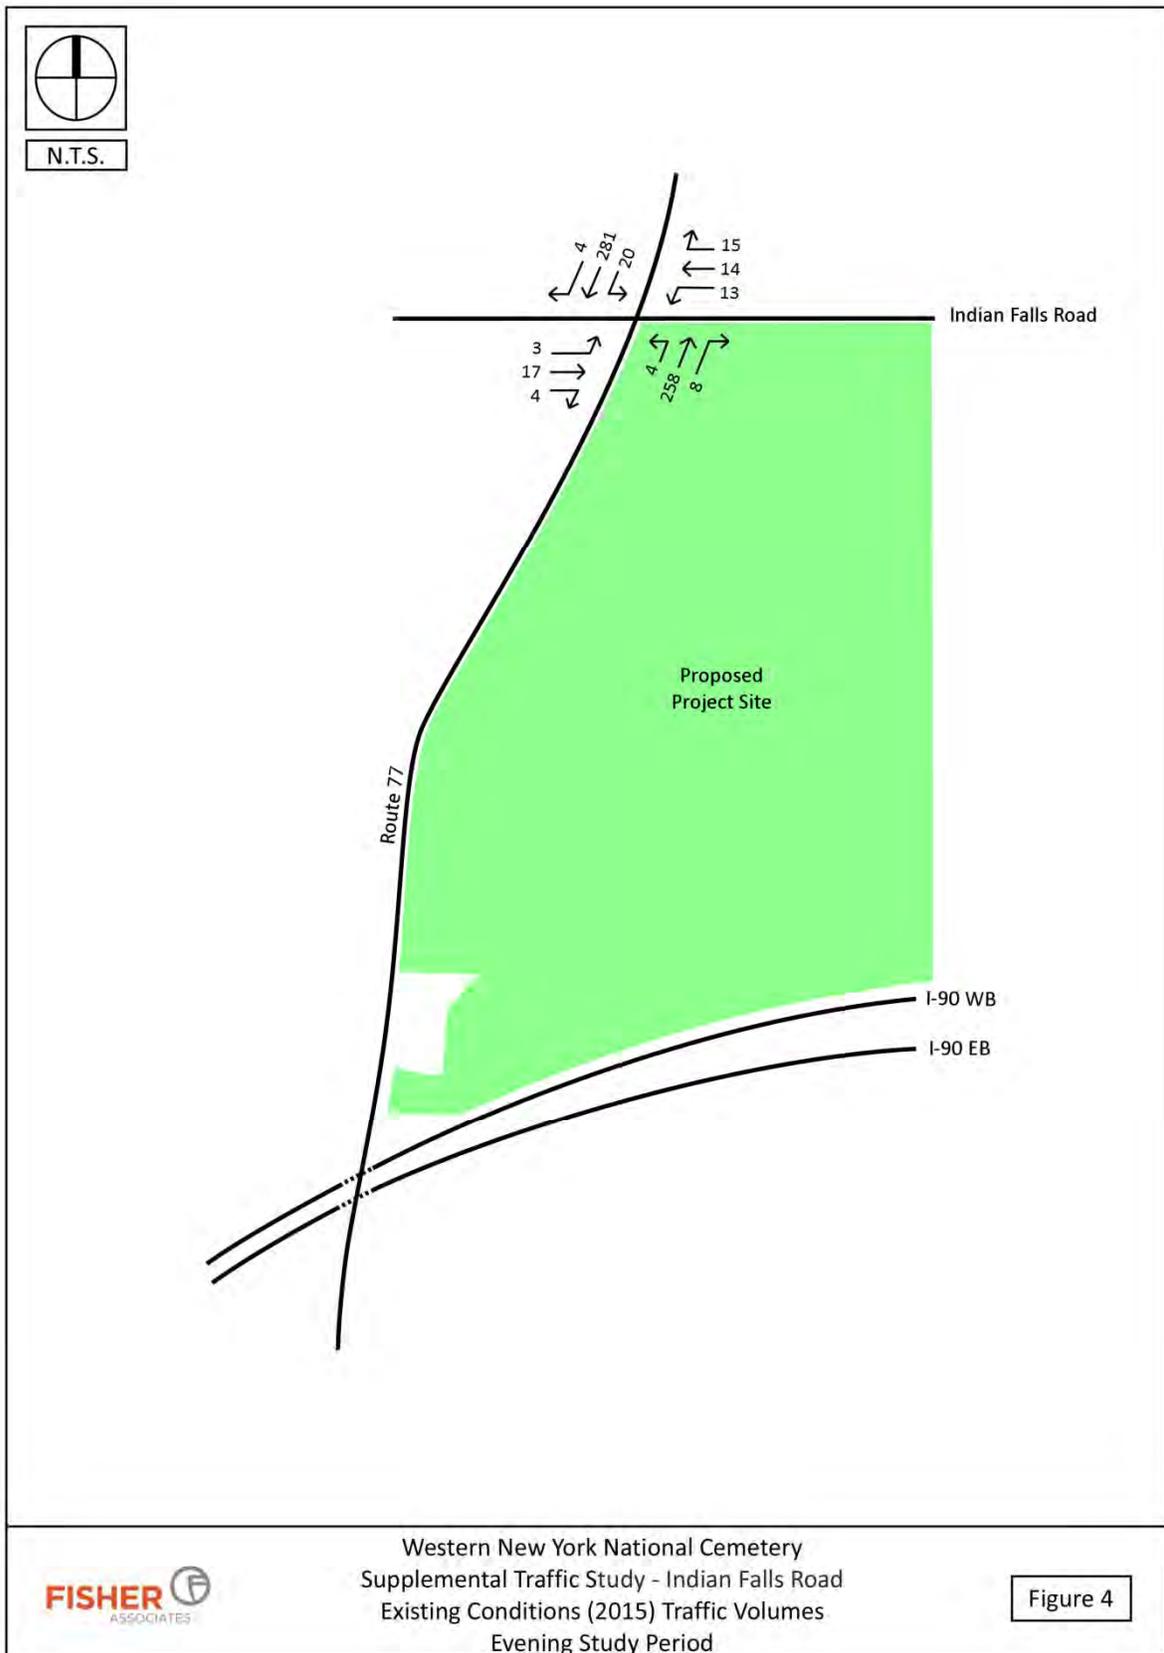
Figure 4

Western New York National Cemetery
Supplemental Traffic Study - Indian Falls Road
Existing Conditions (2015) Traffic Volumes
Evening Study Period

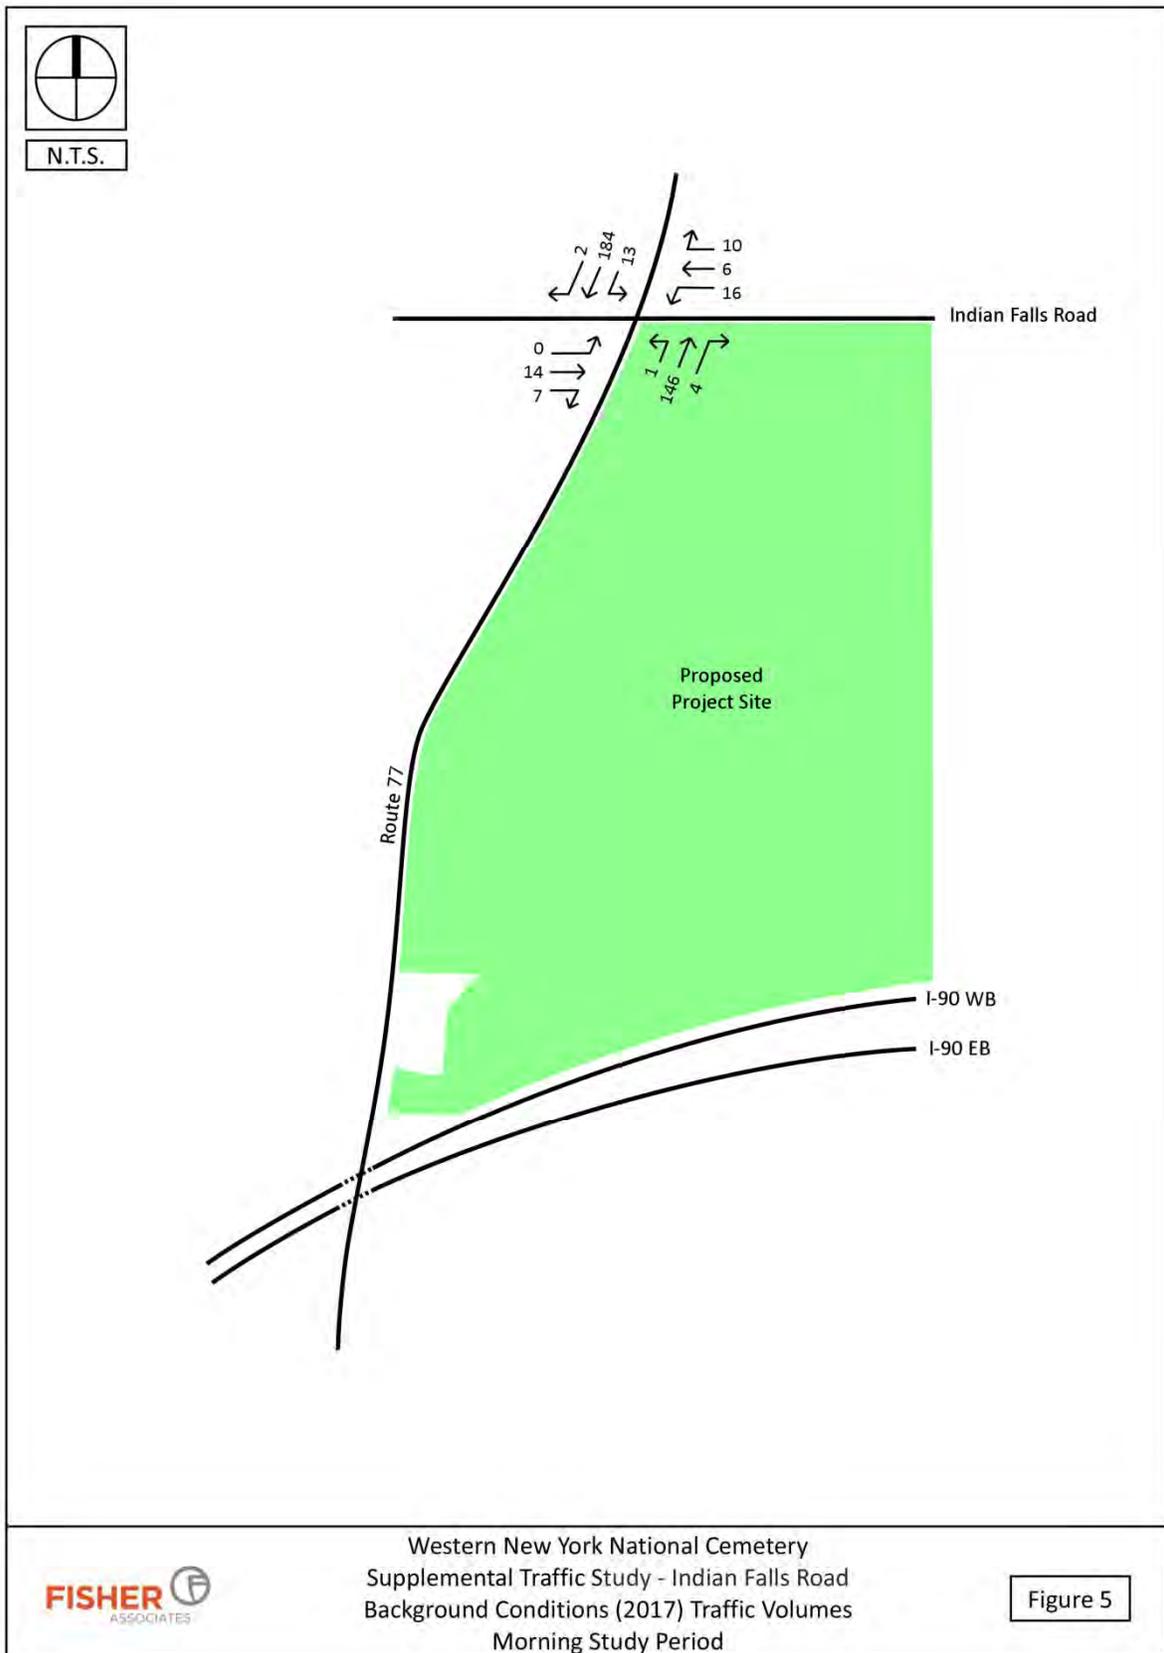
Figure 5

Western New York National Cemetery
Supplemental Traffic Study - Indian Falls Road
Background Conditions (2017) Traffic Volumes
Morning Study Period

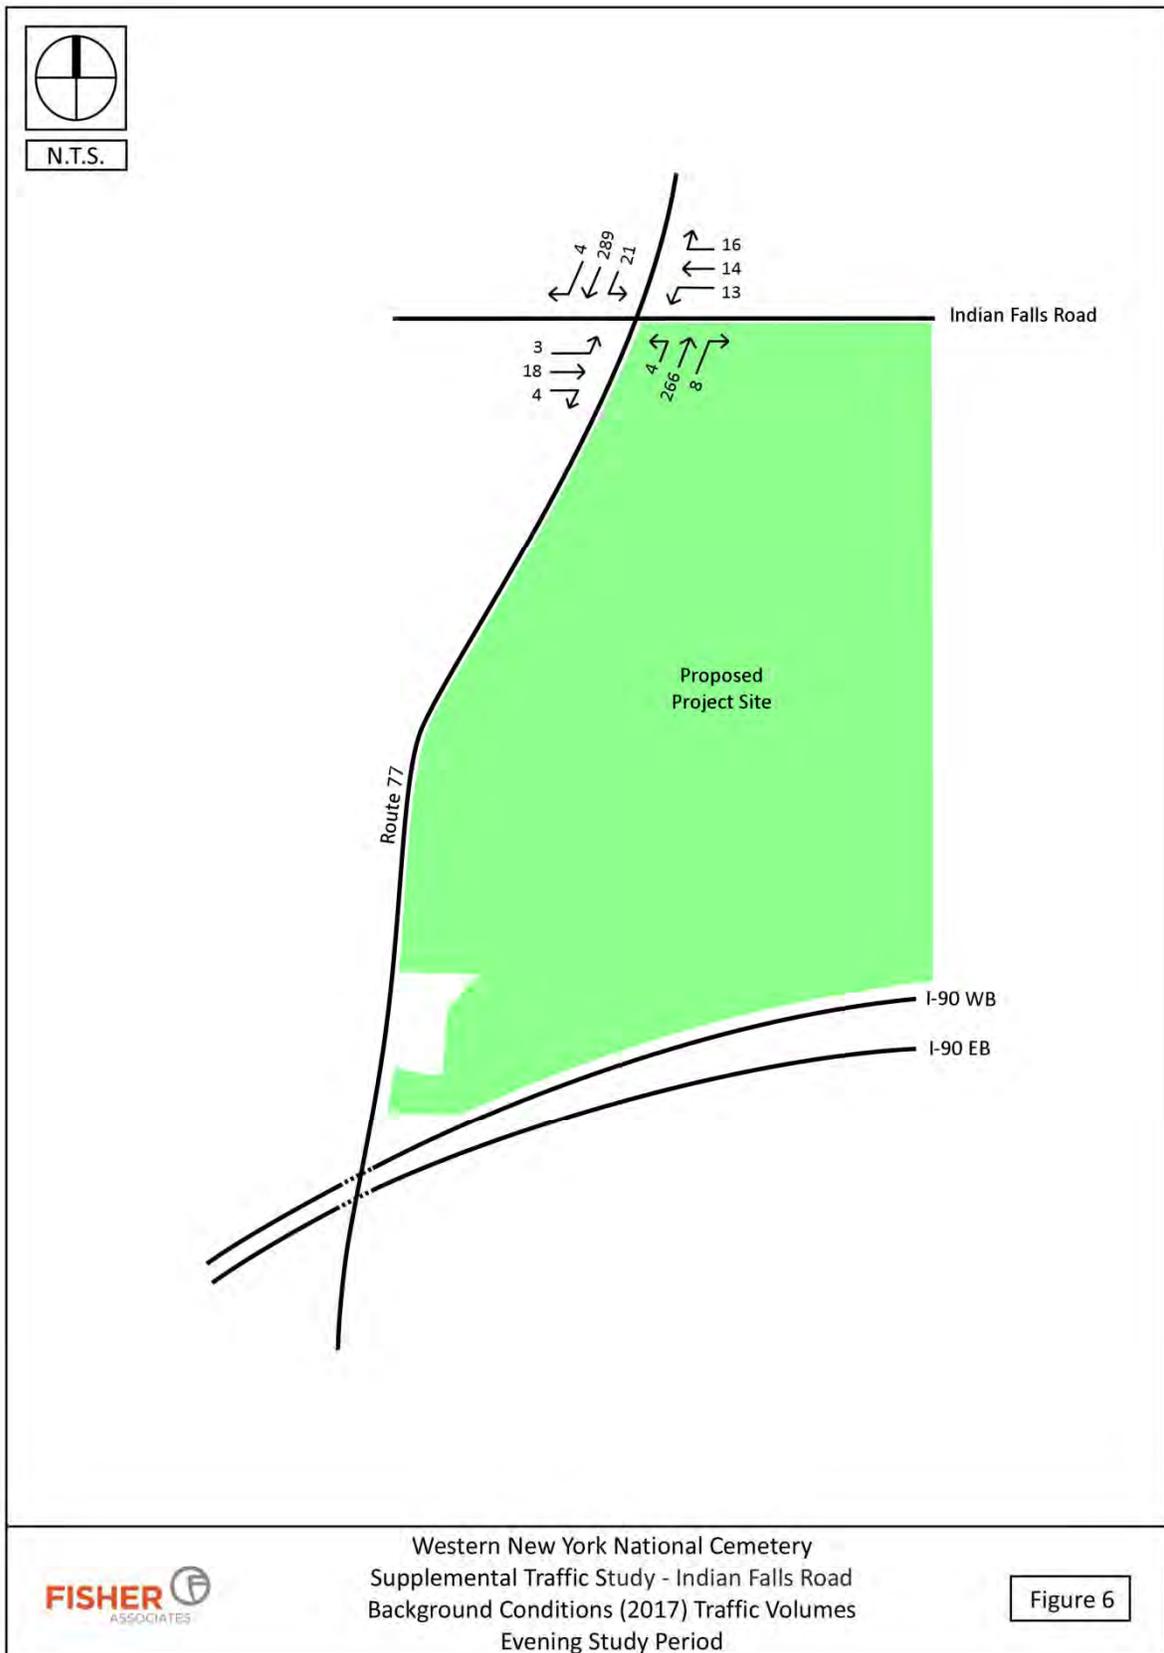
Figure 6

Western New York National Cemetery
Supplemental Traffic Study - Indian Falls Road
Background Conditions (2017) Traffic Volumes
Evening Study Period

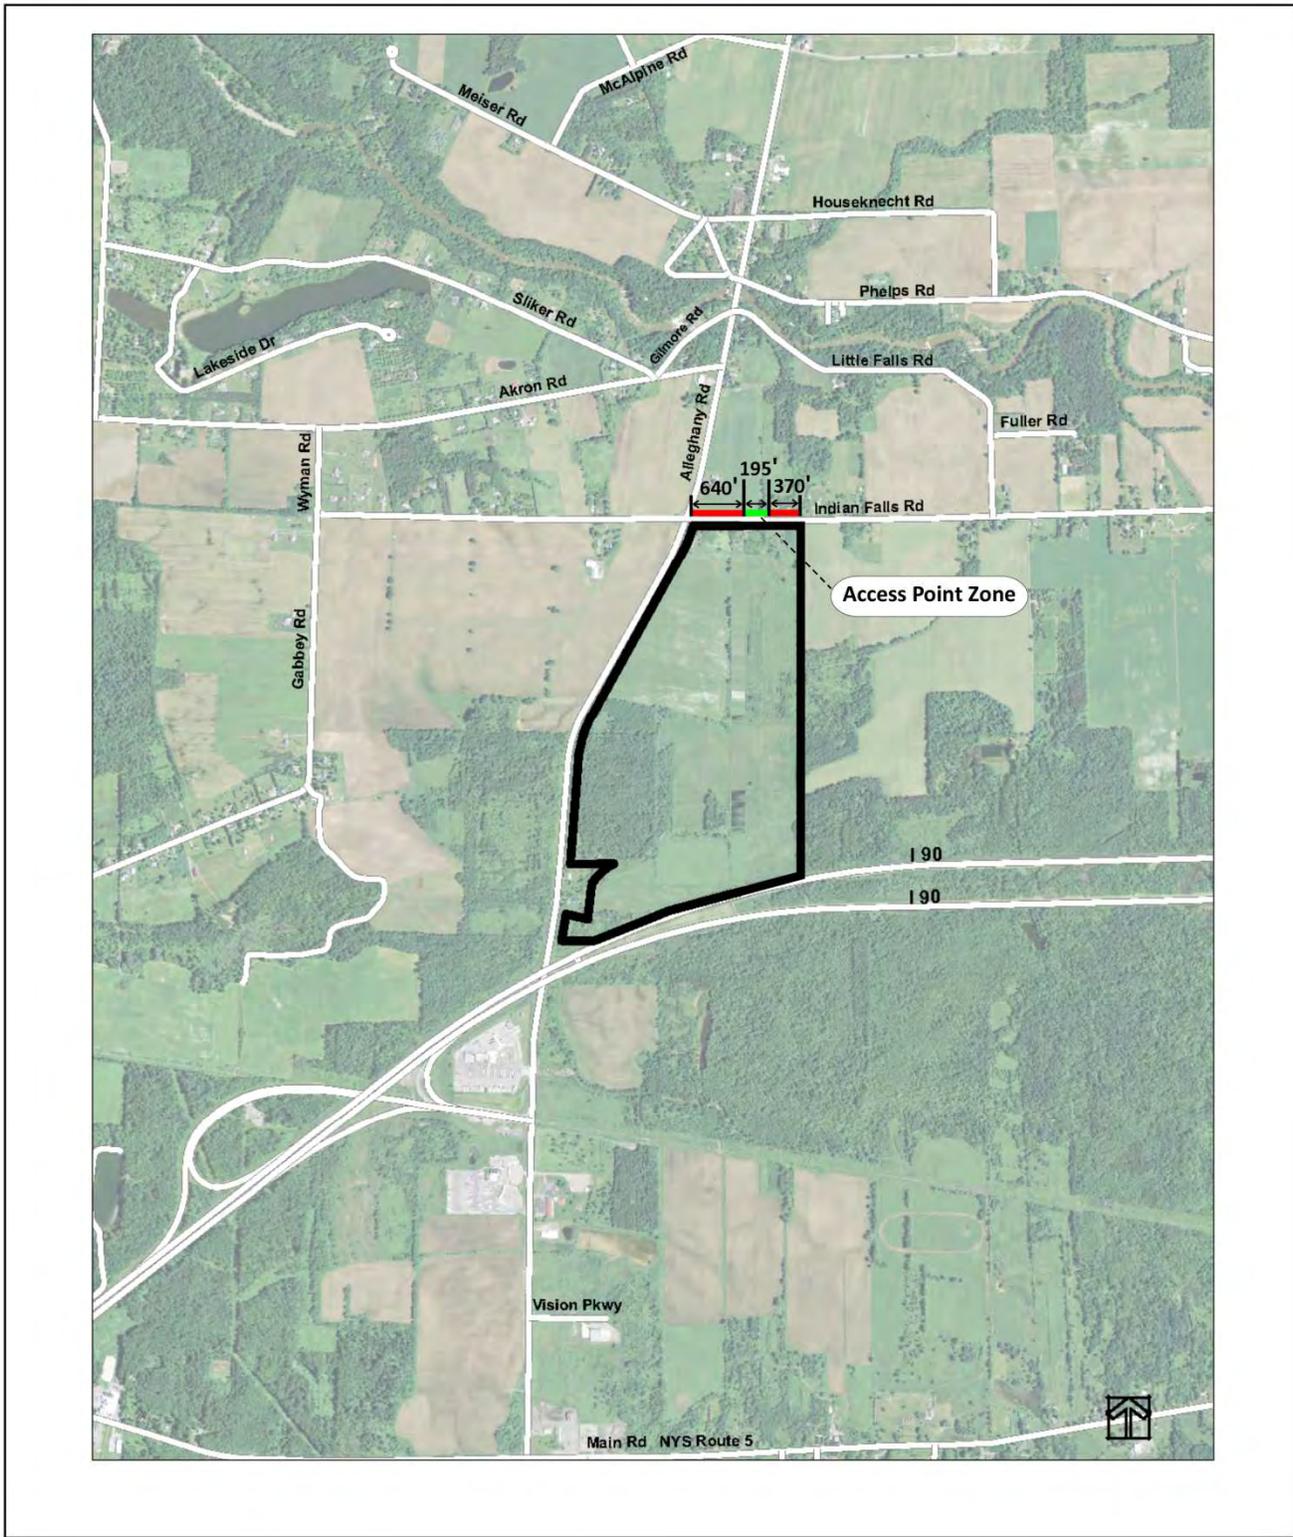
Figure 7

Western New York National Cemetery
Supplemental Traffic Study - Indian Falls Road
Public Access Point Zone Map
