MEMORANDUM OF AGREEMENT
AMONG THE NATIONAL CEMETERY ADMINISTRATION OF THE U.S. DEPARTMENT OF
VETERANS AFFAIRS, THE TONAWANDA SENECA NATION, THE NEW YORK STATE
HISTORIC PRESERVATION OFFICE, AND THE ESTATE OF LEROY VEENENDAAL,
REGARDING ESTABLISHMENT OF A NEW NATIONAL CEMETERY AT AN
APPROXIMATELY 132-ACRE SITE LOCATED AT 1232 INDIAN FALLS ROAD, GENESEE
COUNTY, NY (SHPO Project Review No.12PR2608)

**Phase 3 Data Recovery Plan for the Indian Falls V.A. Precontact Site (A03712.000035)
at the Proposed Western New York U.S. Department of Veterans Affairs Cemetery Location
in East Pembroke, New York**

**Western New York National Cemetery
Traffic Study**

**Western New York National Cemetery
Supplemental Traffic Study – Indian Falls Road**

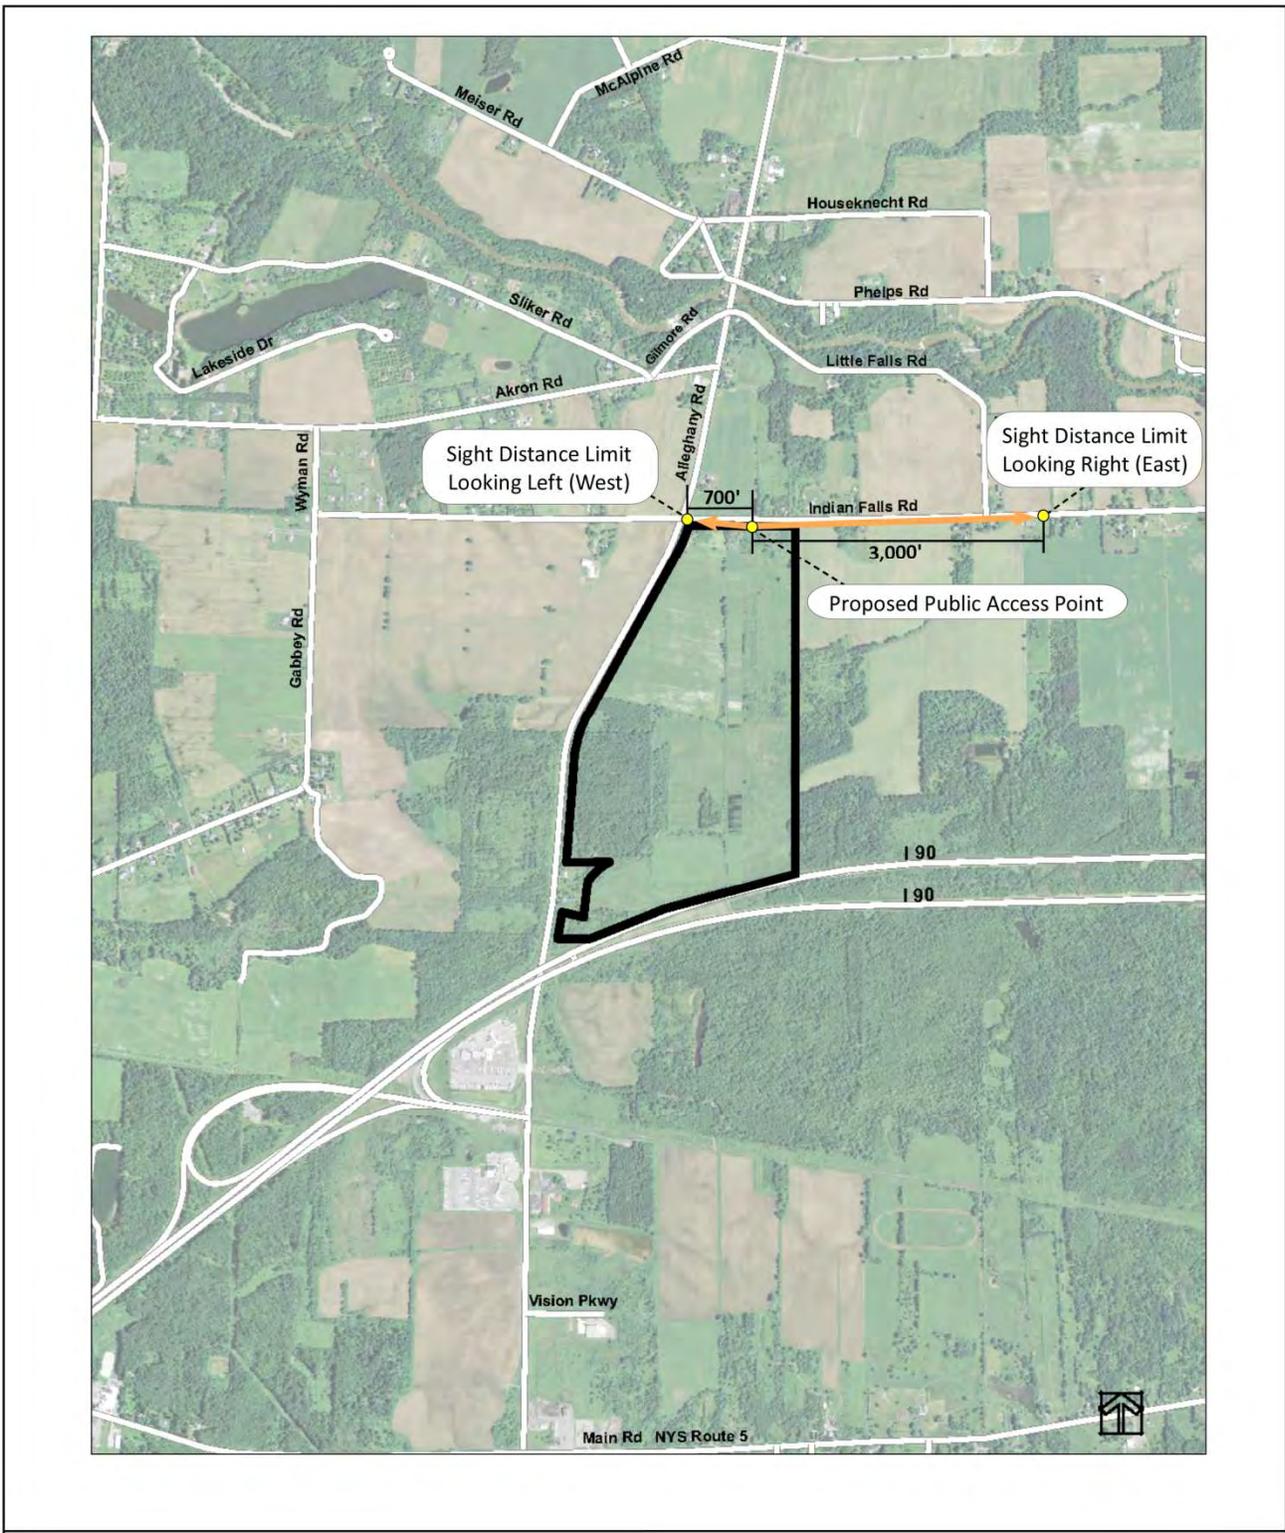
Figure 8

Western New York National Cemetery
Supplemental Traffic Study - Indian Falls Road
Proposed Public Access Point - Observed Intersection Sight Distances

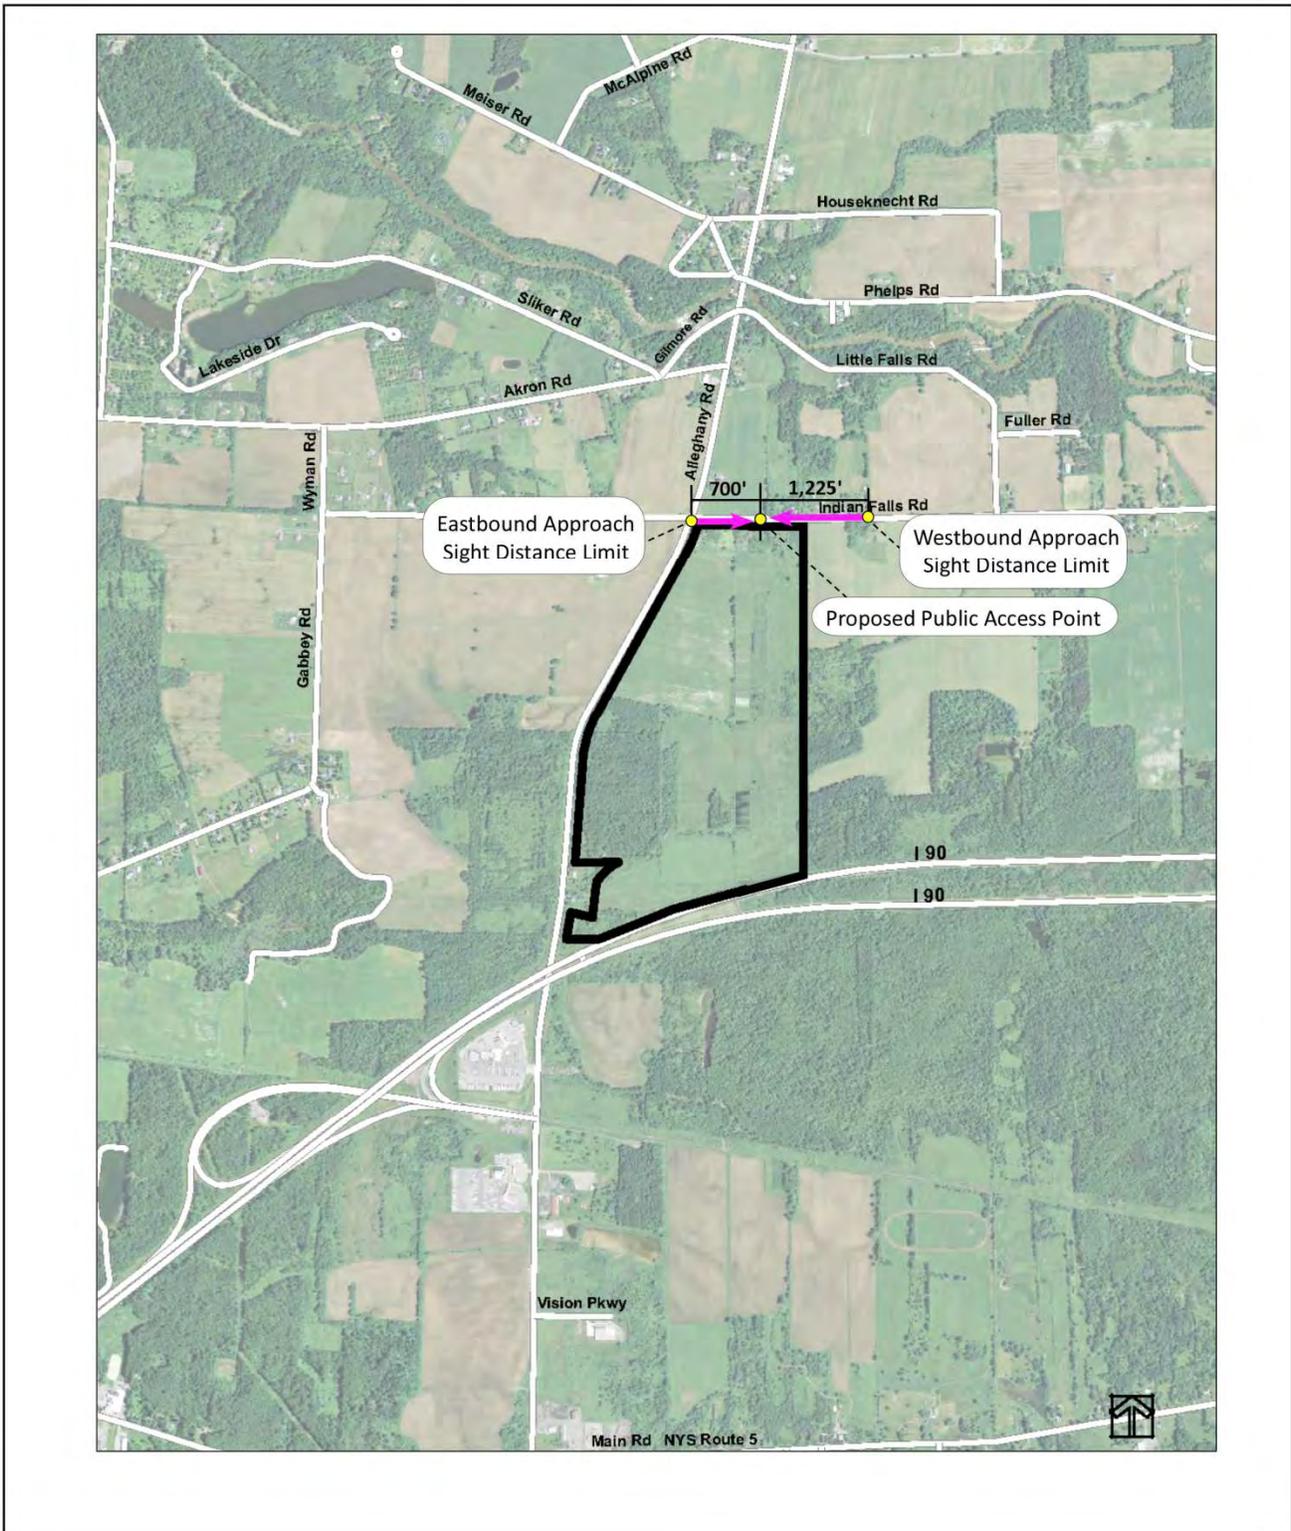
Figure 9

Western New York National Cemetery
Supplemental Traffic Study - Indian Falls Road
Proposed Public Access Point - Observed Stopping Sight Distances

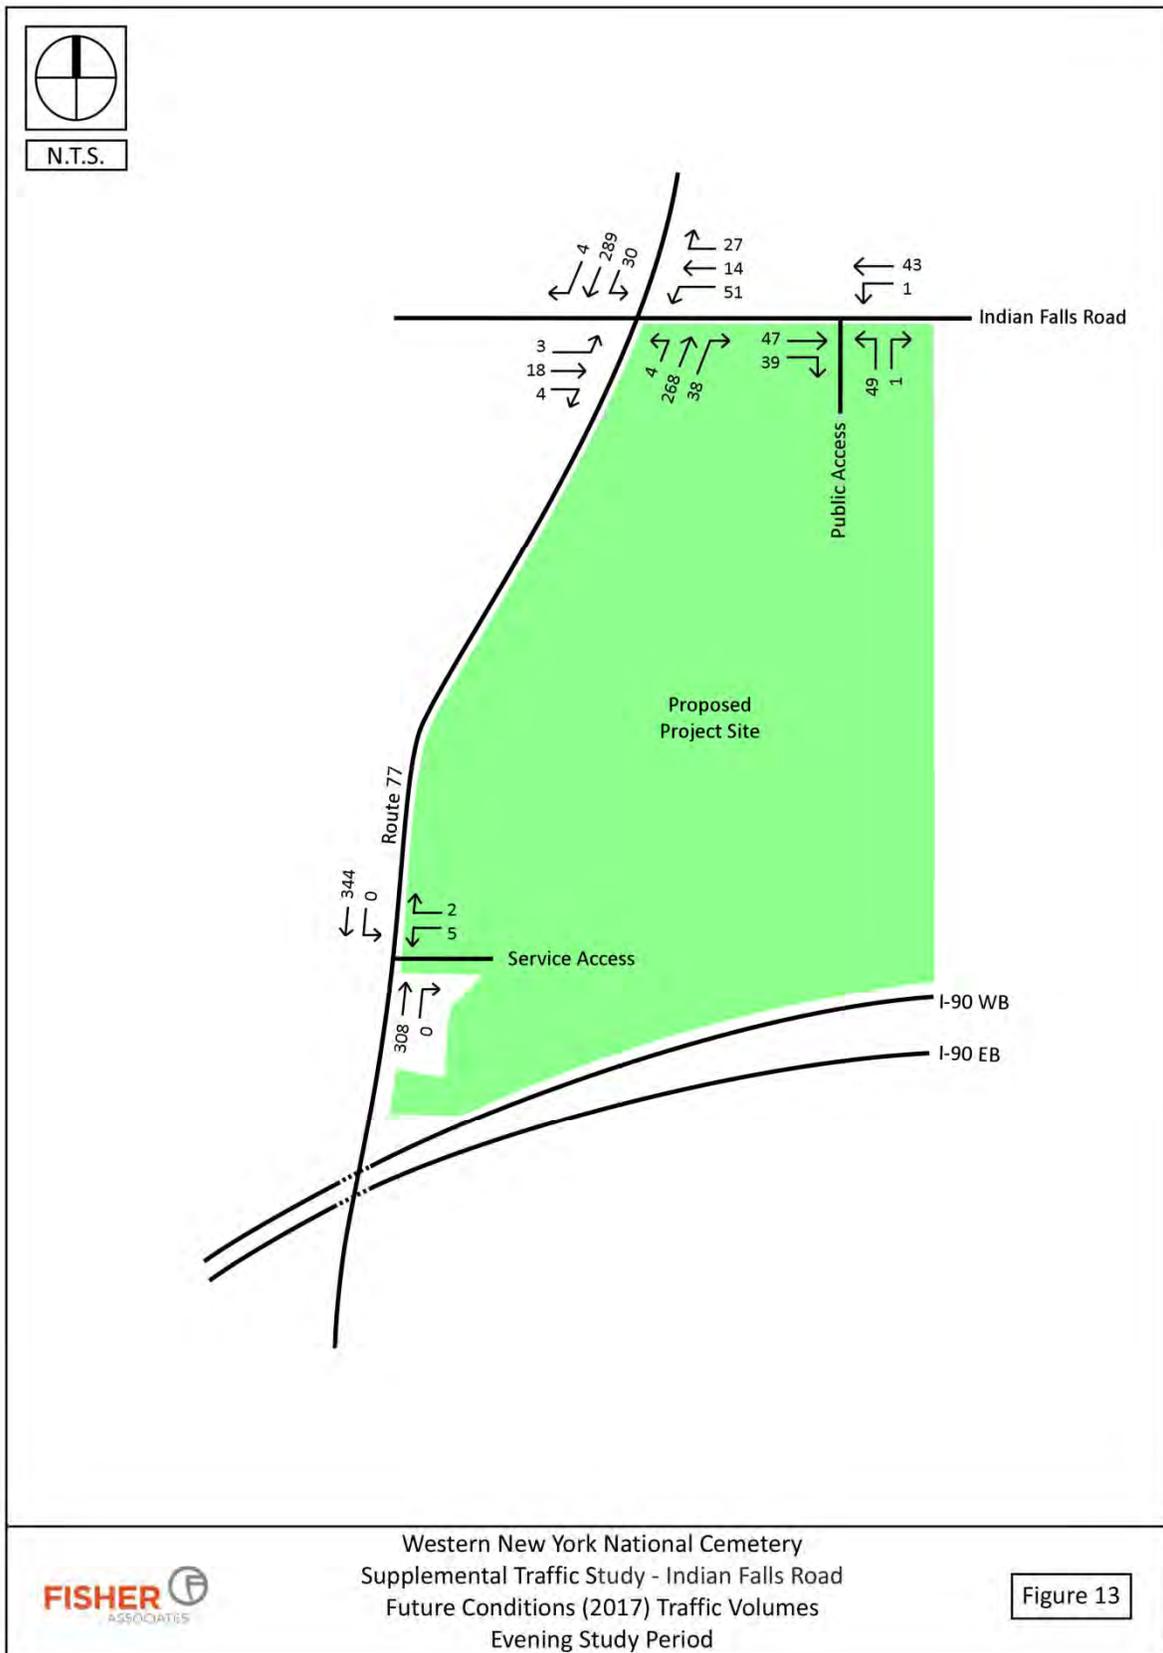
Figure 13

Western New York National Cemetery
Supplemental Traffic Study - Indian Falls Road
Future Conditions (2017) Traffic Volumes
Evening Study Period

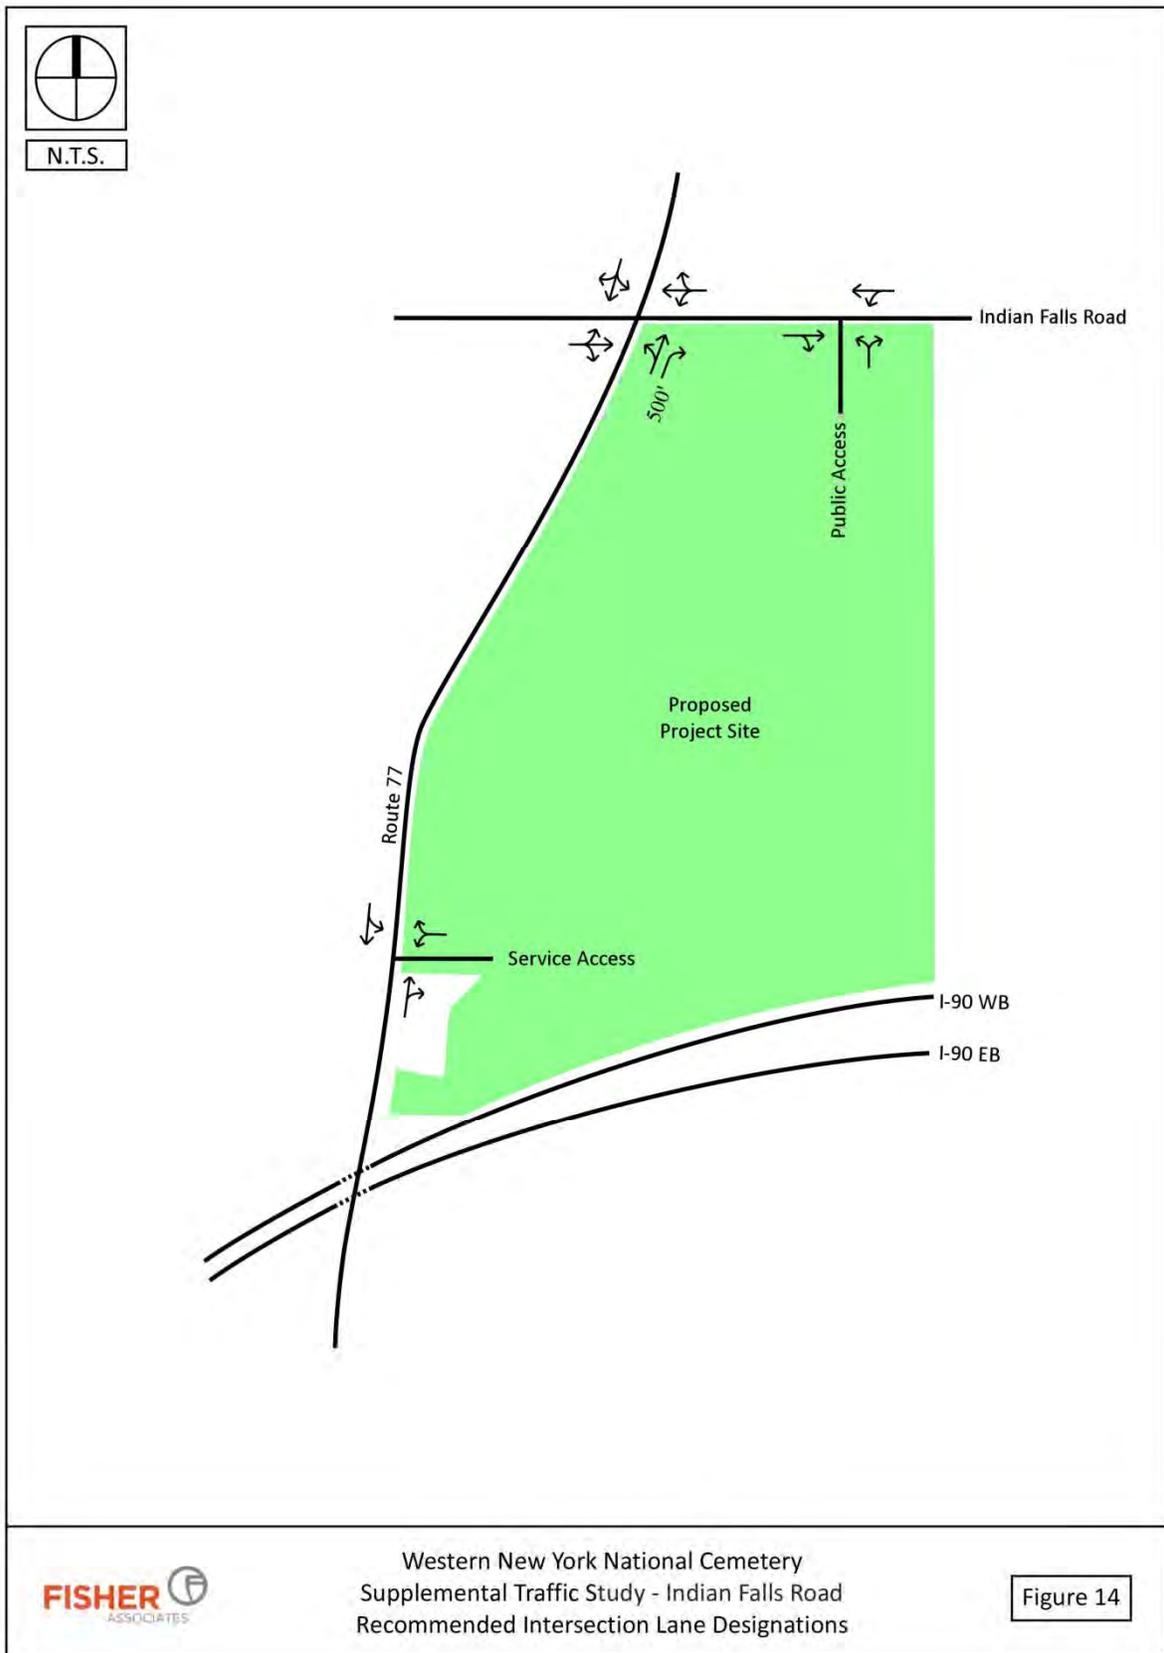
Figure 14

Western New York National Cemetery
Supplemental Traffic Study - Indian Falls Road
Recommended Intersection Lane Designations

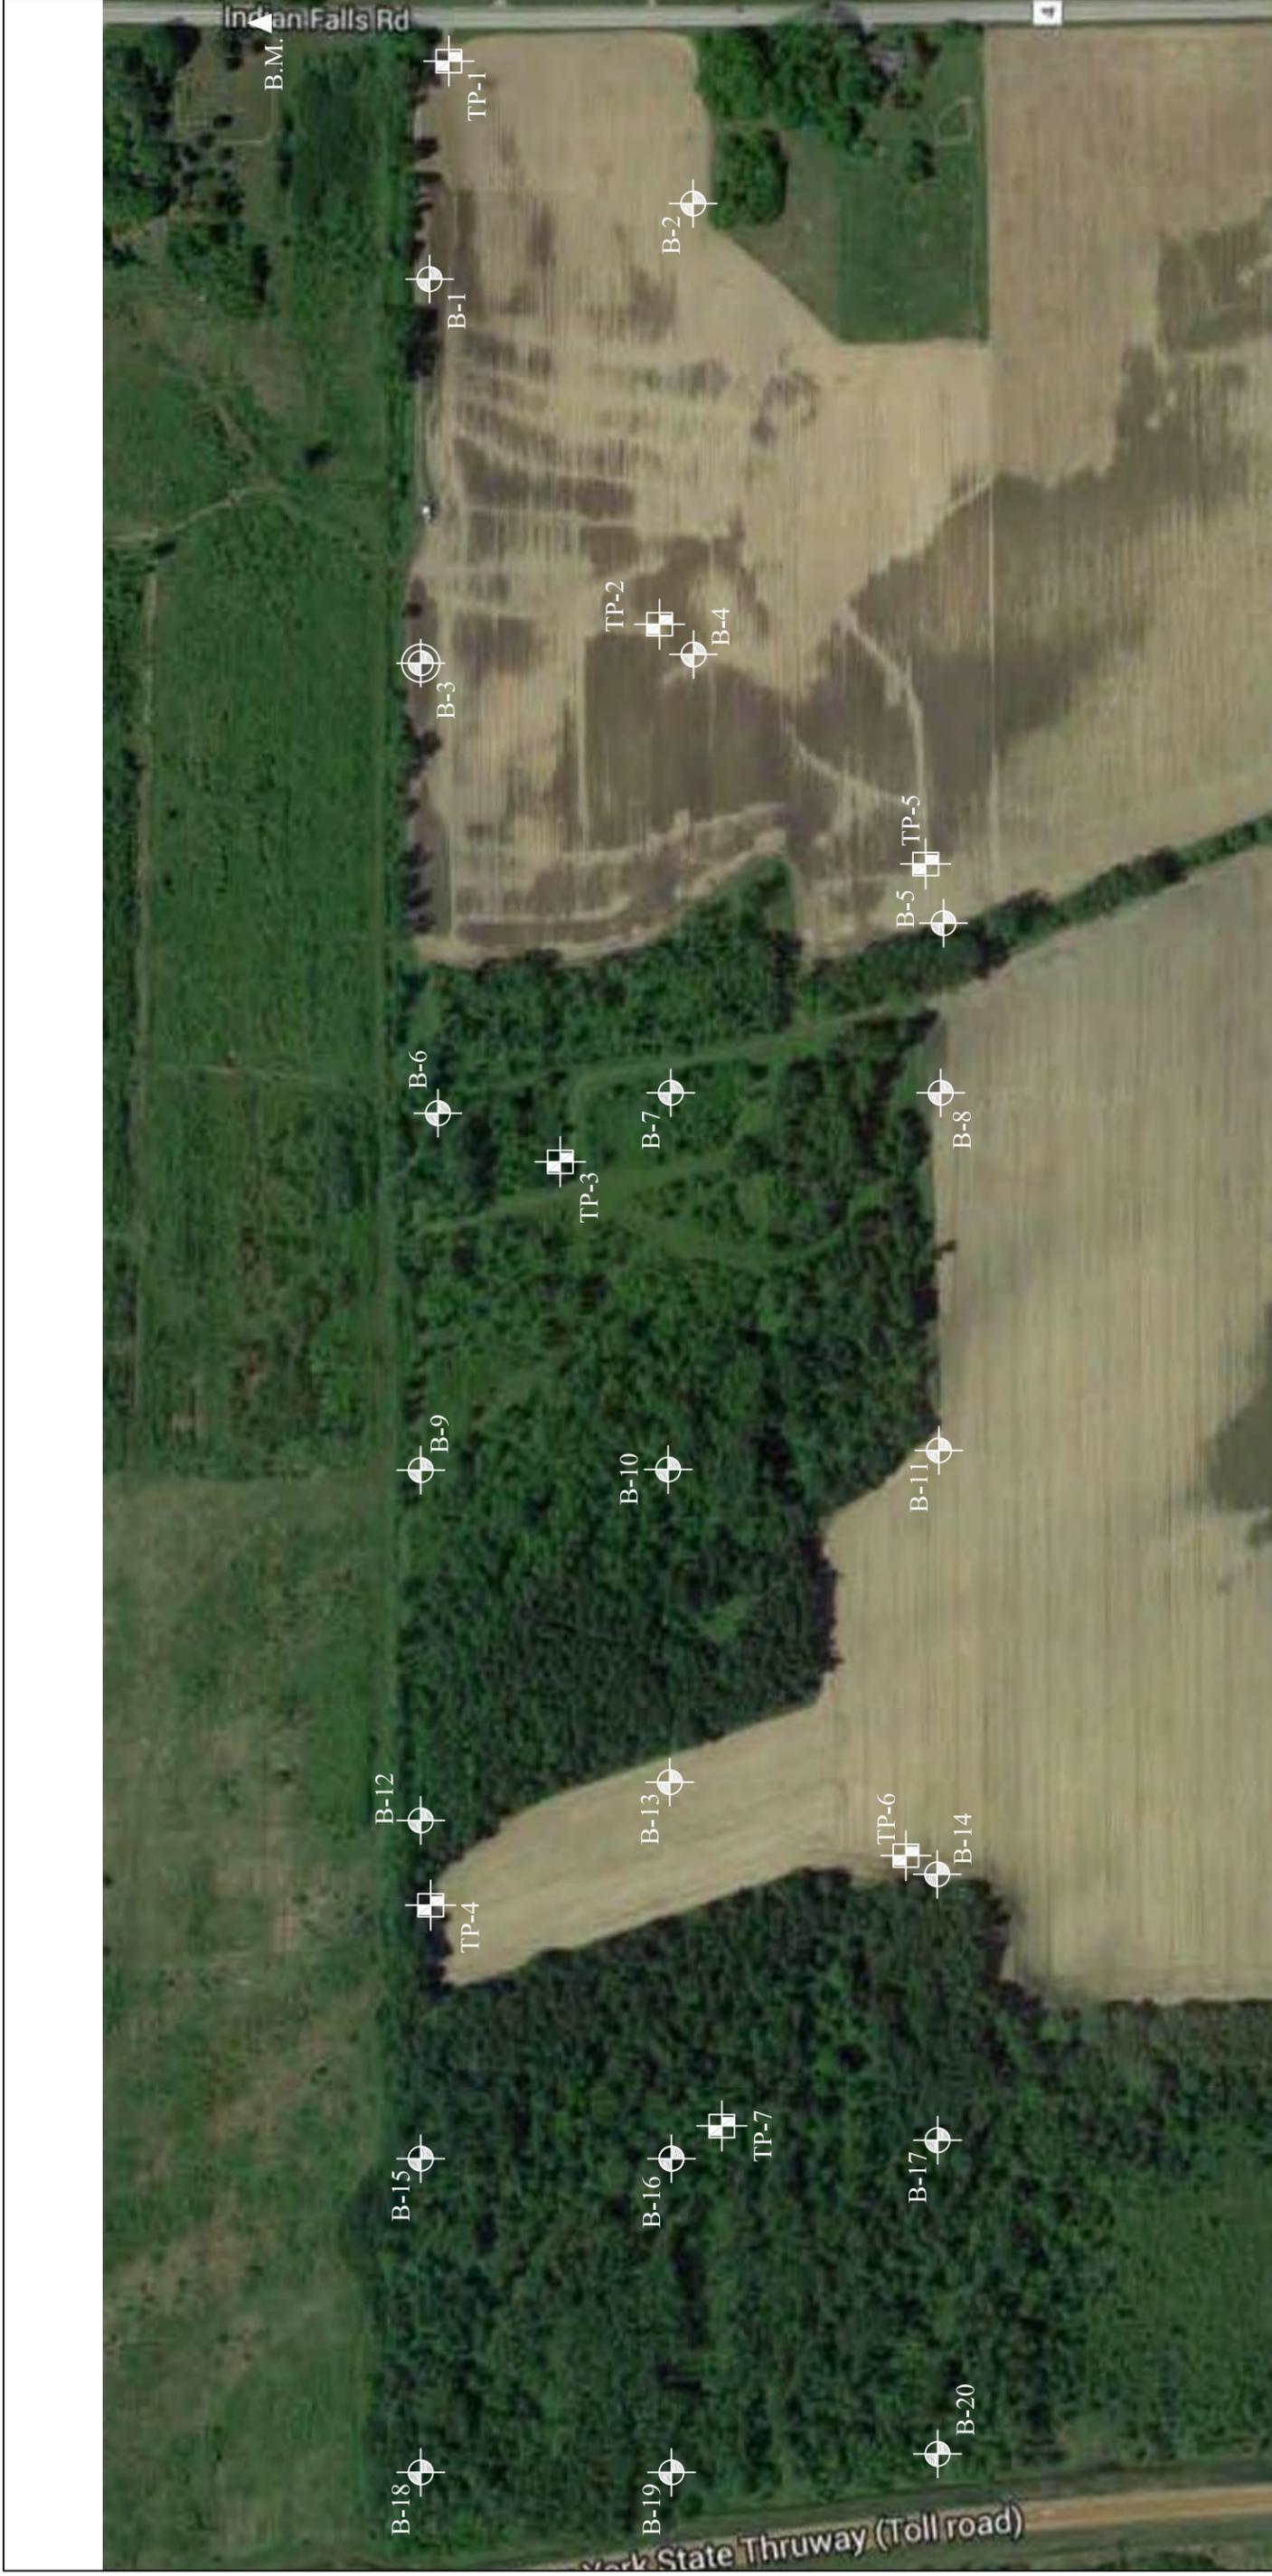
- B-1 INDICATES APPROXIMATE LOCATION AND DESIGNATION OF TEST BORING.
- B-3 INDICATES APPROXIMATE LOCATION AND DESIGNATION OF TEST BORING COMPLETED WITH GROUNDWATER OBSERVATION WELL.

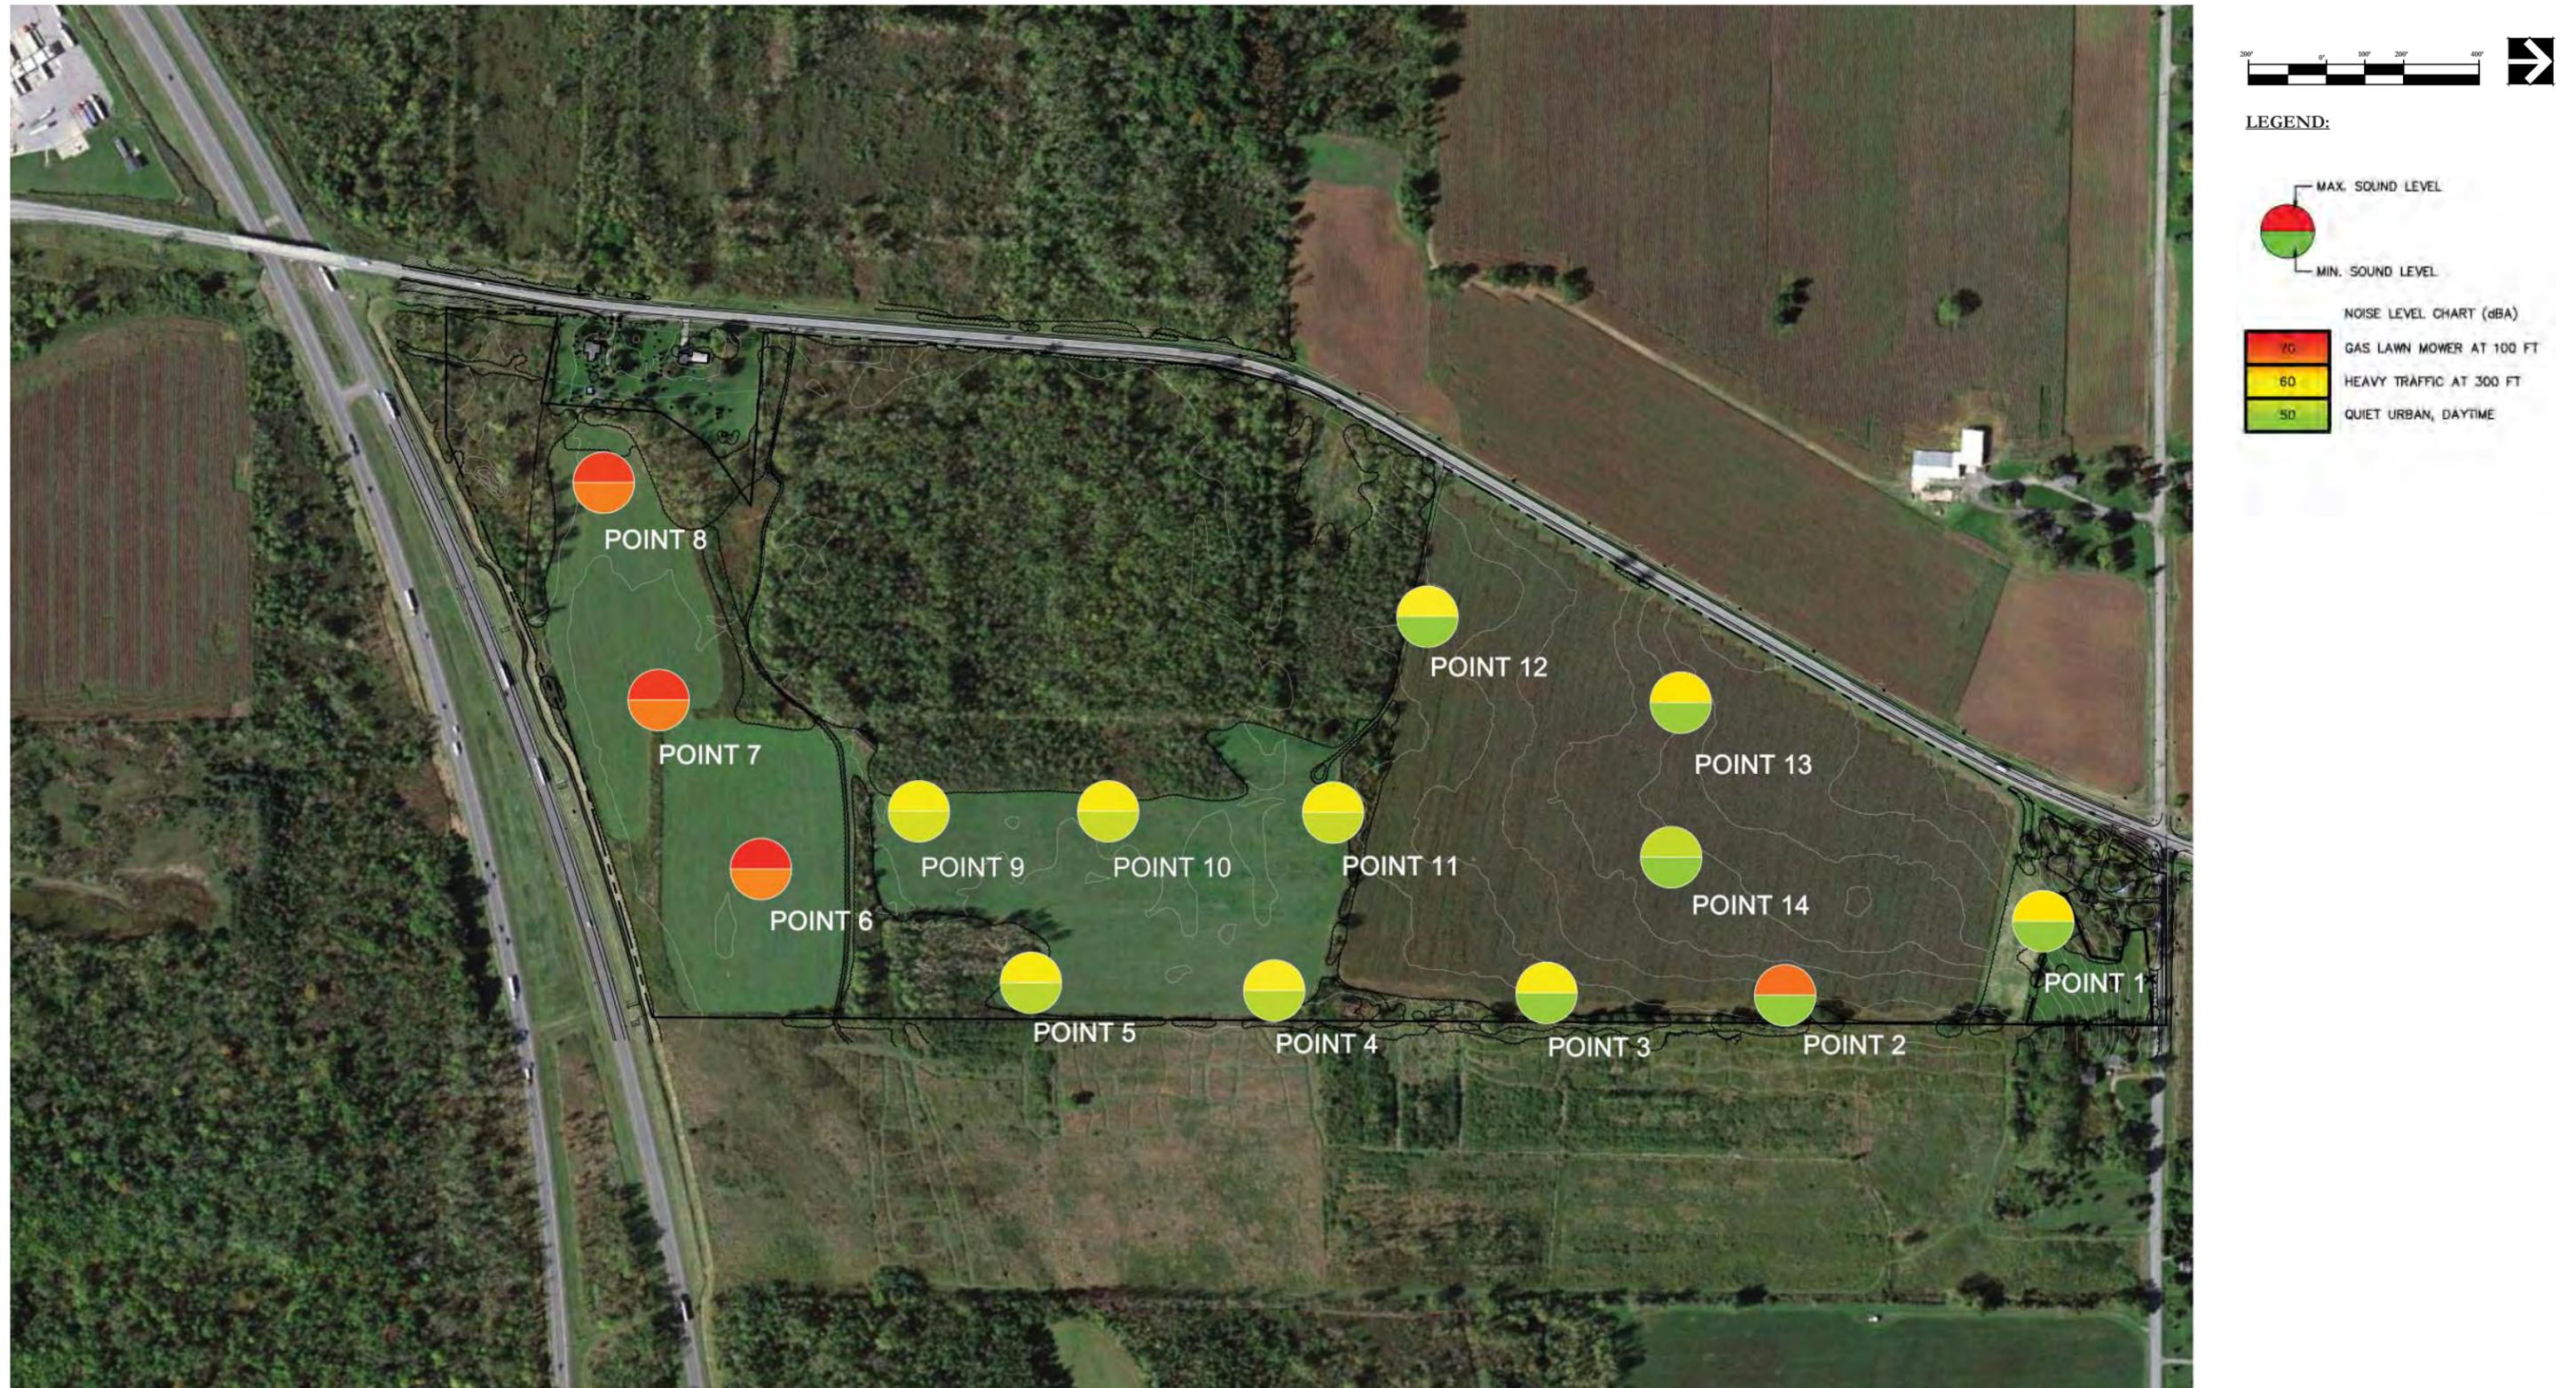
Figure 2.11.A | Sound Study Location Map

WNY Sound Level Readings April 28, 2015*
